Black Butte School District

Facility Condition Assessment Report

Camp Sherman, Oregon

Assessment: December 2020

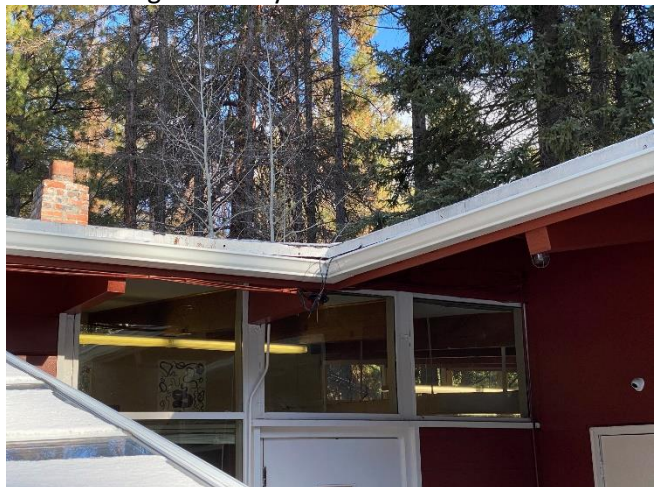
Roof Drainage at Valley over Back Door

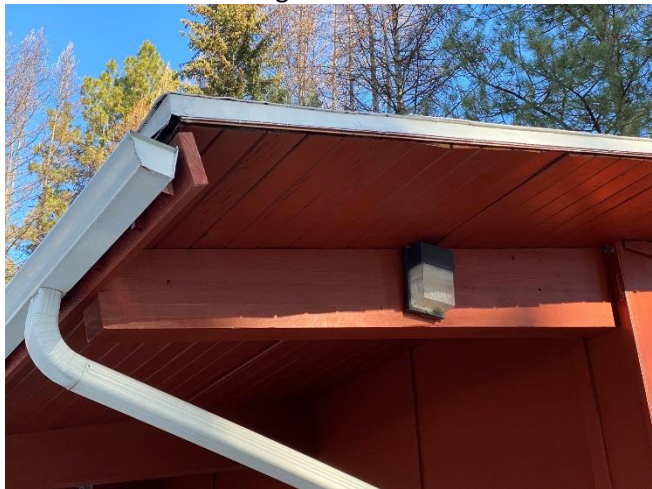
Fascia and Soffit Damage

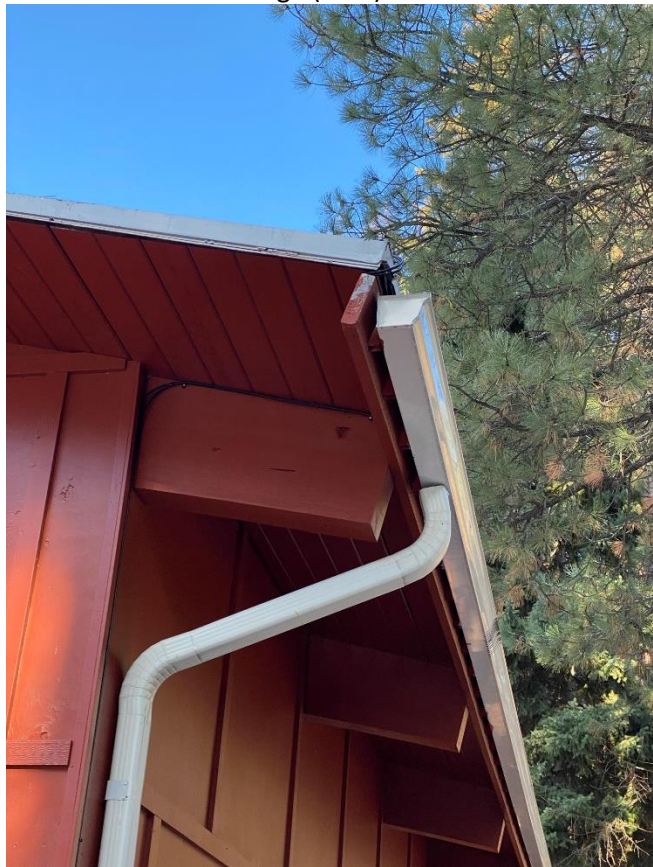
Fascia and Soffit Damage (cont).

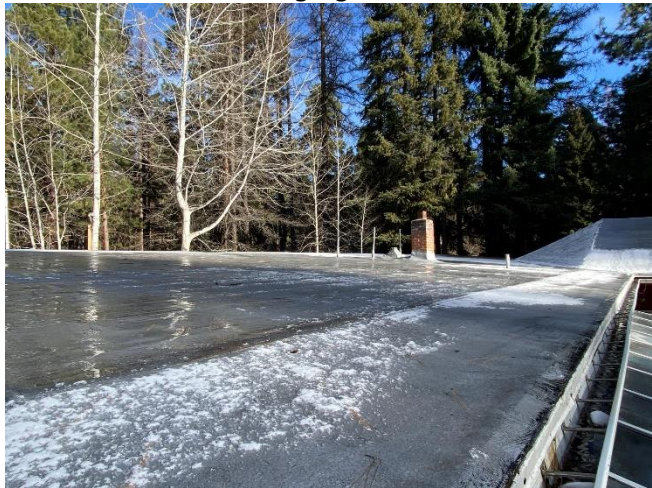
Membrane Roof Showing Significant Wear

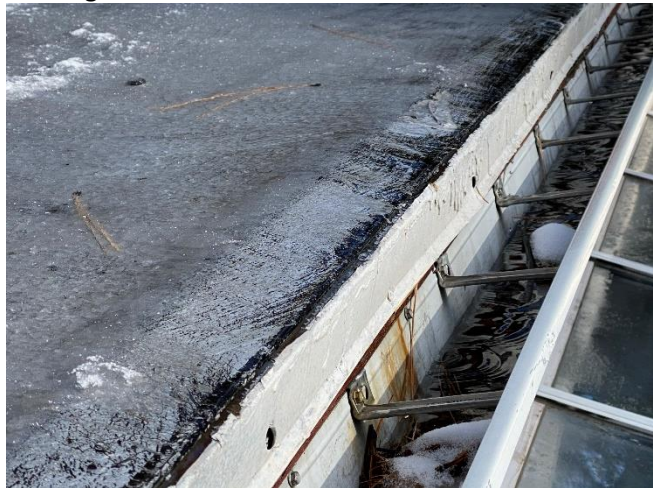
Roofing Close to Failure at Gutters

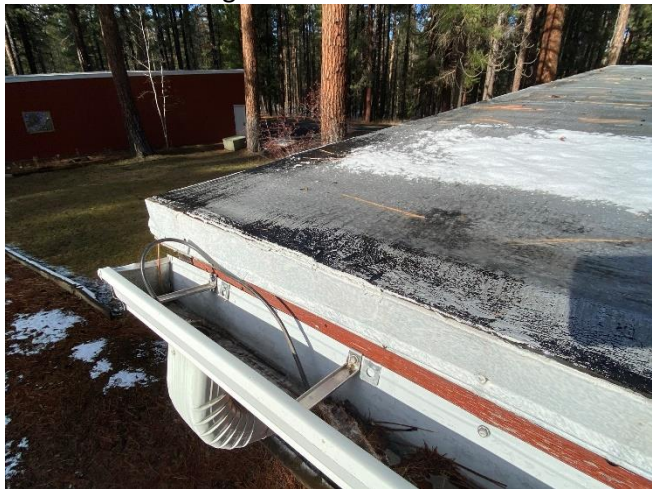
Membrane Roofing Close to Failure

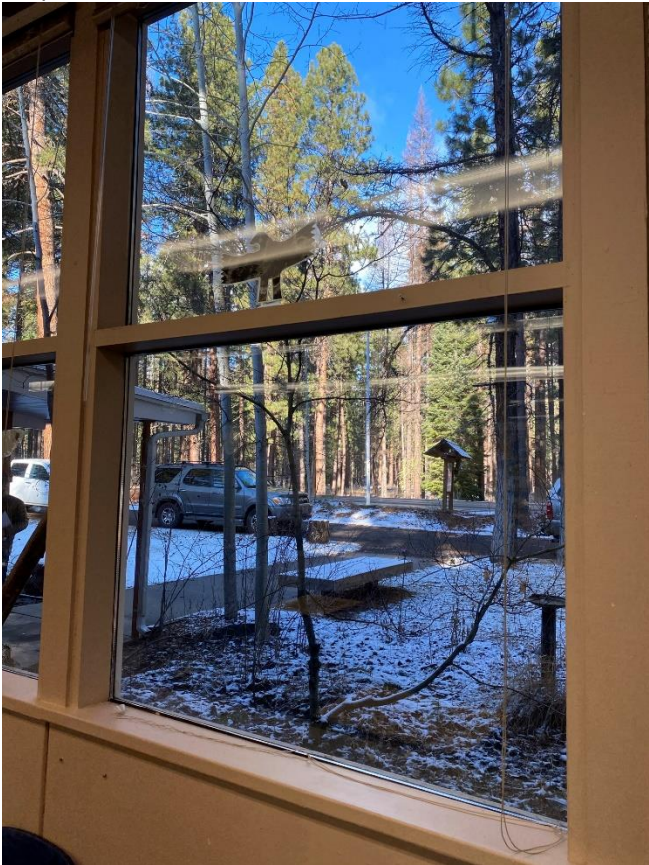
Inoperable Windows

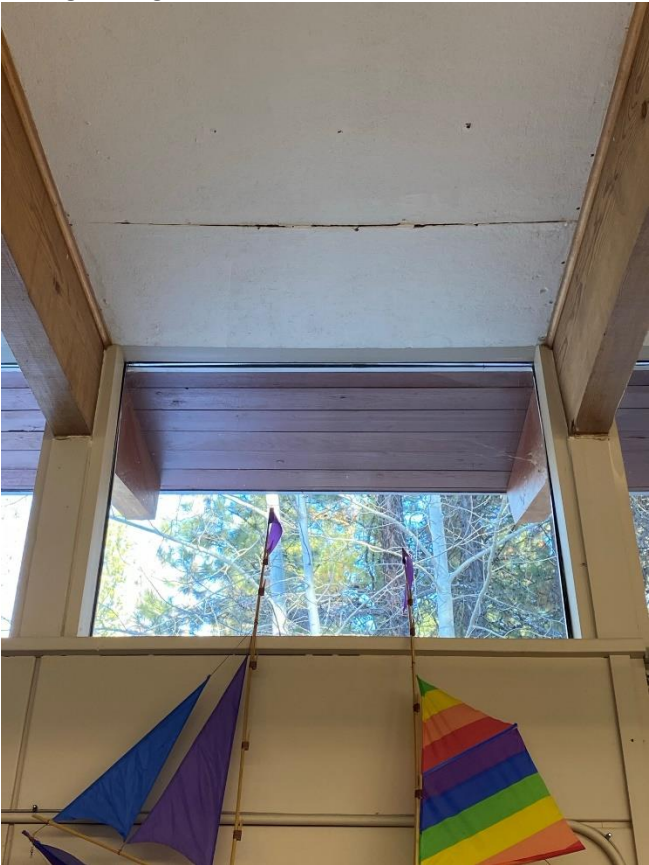
Failing Ceiling Panels

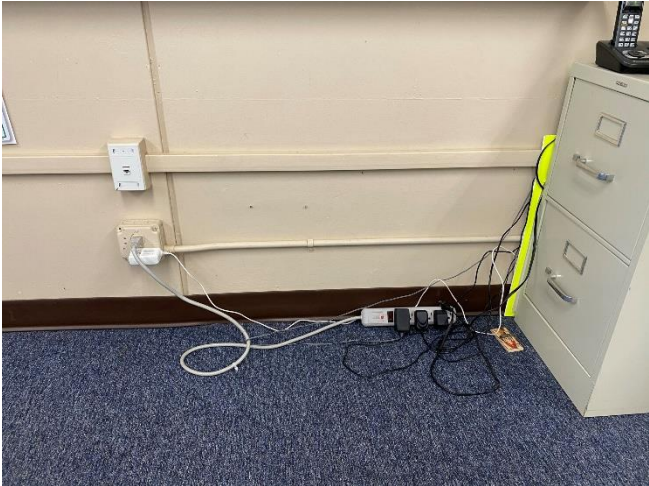
Inadequate Power Supply

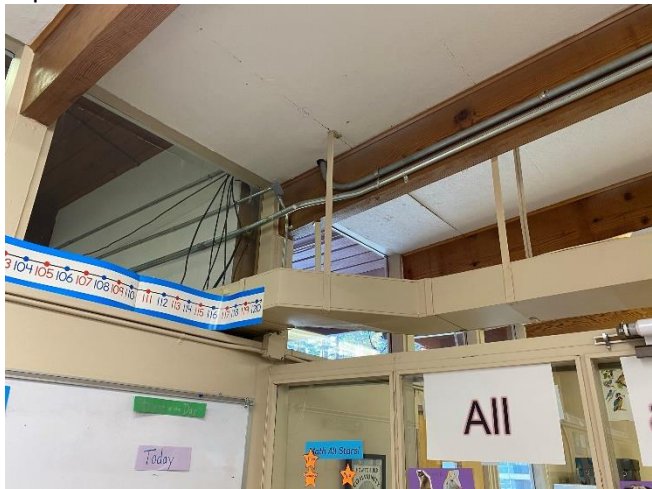
Exposed Conduits

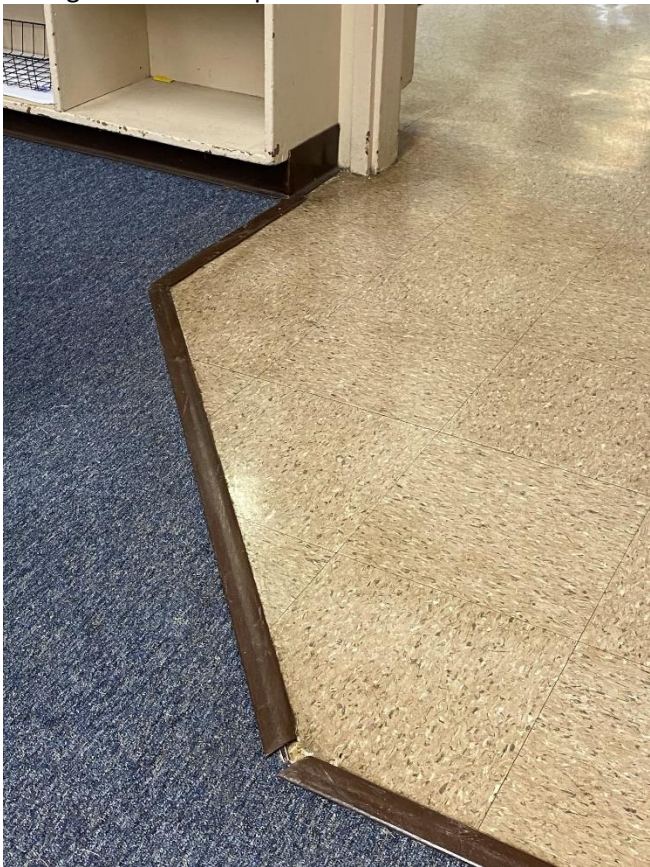
Failing Transition Strip

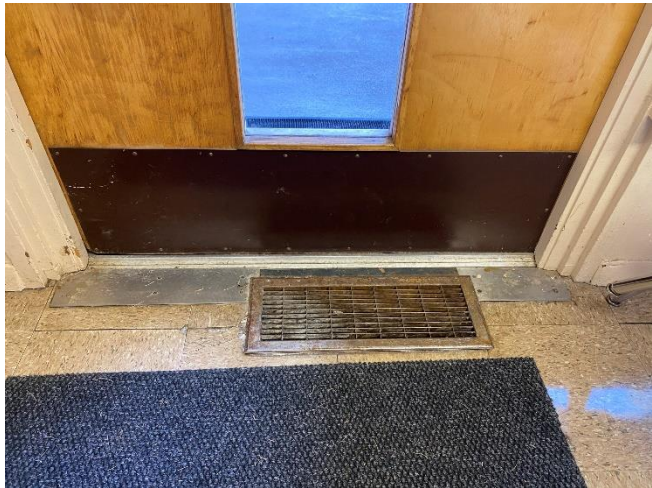
Cracked Floor Tiles

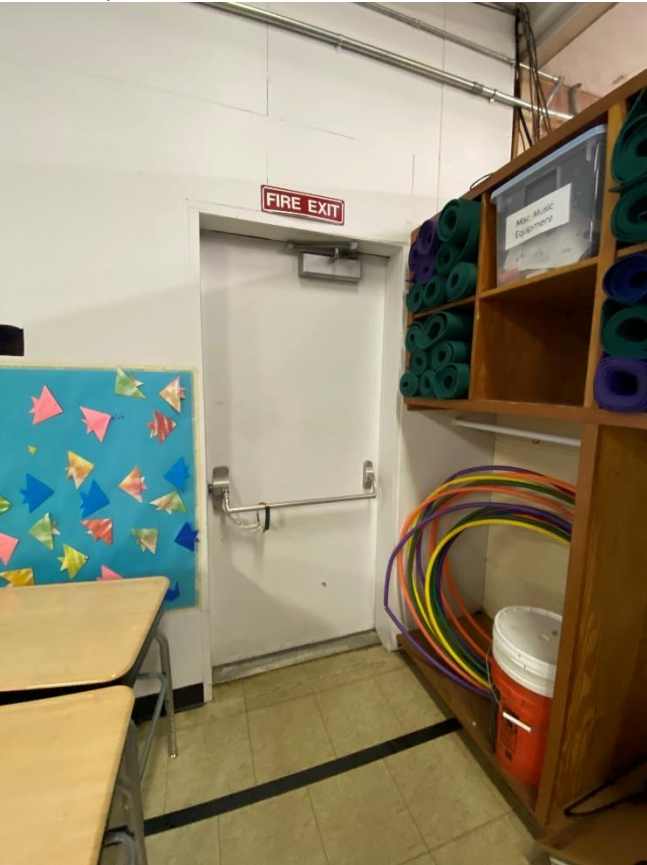
No Ability to Lock Door from Inside

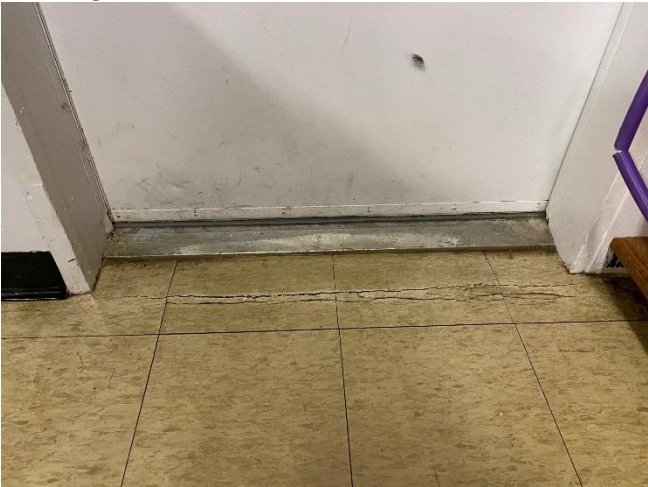
Cracking Floor Tiles

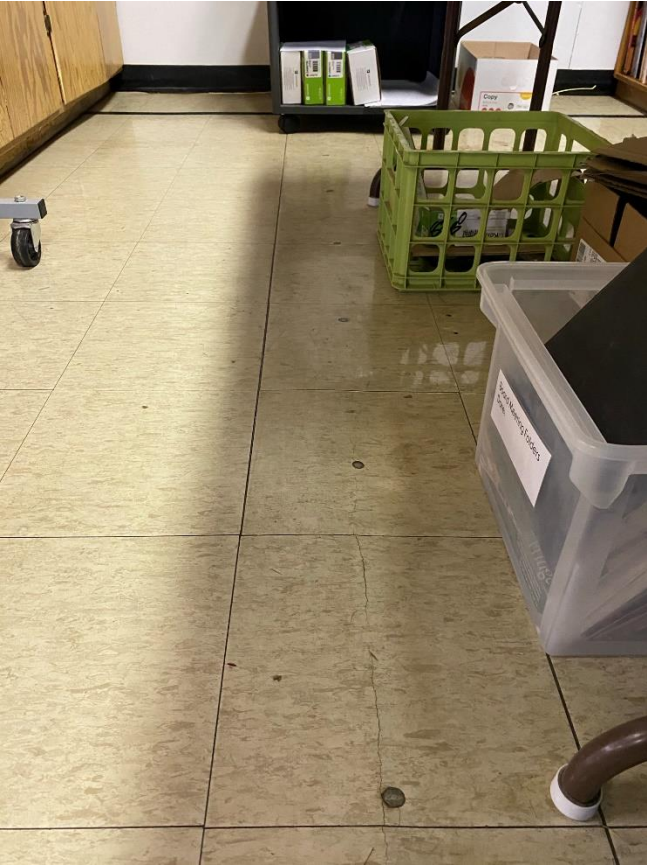
Cracking Floor Tiles at Slab Settlement Crack

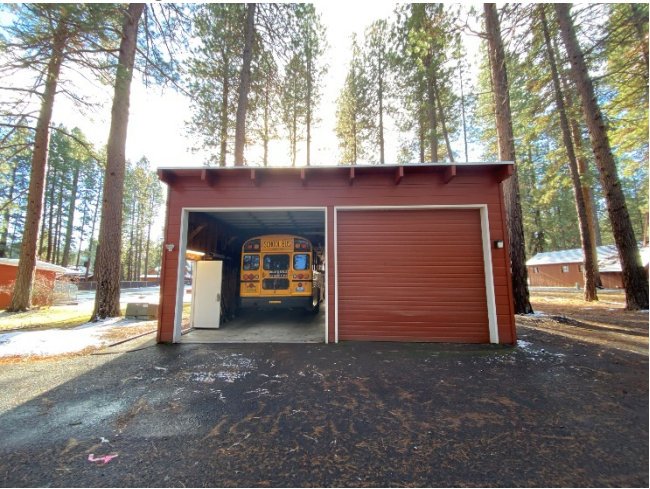
Dented Garage Doors

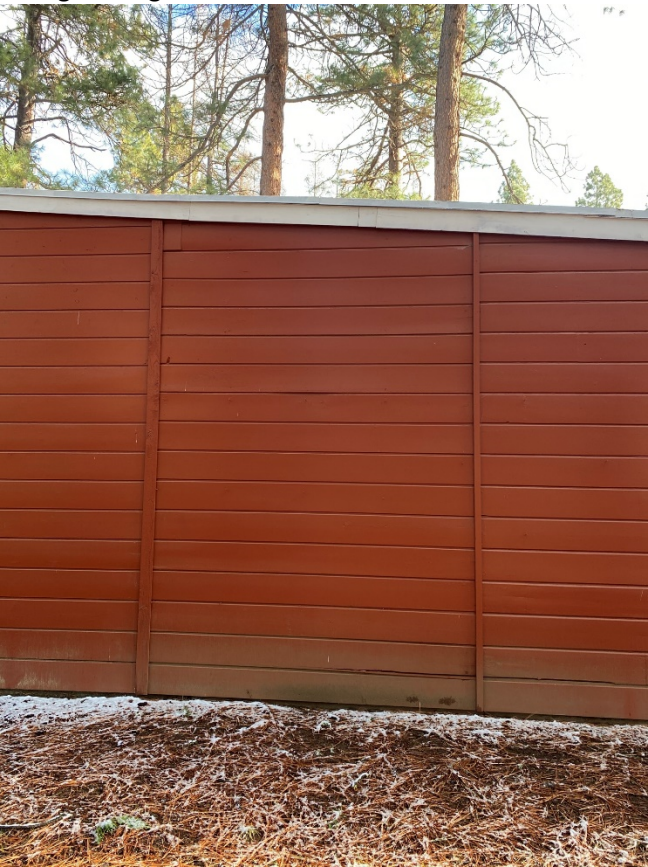
Siding Damage at Grade

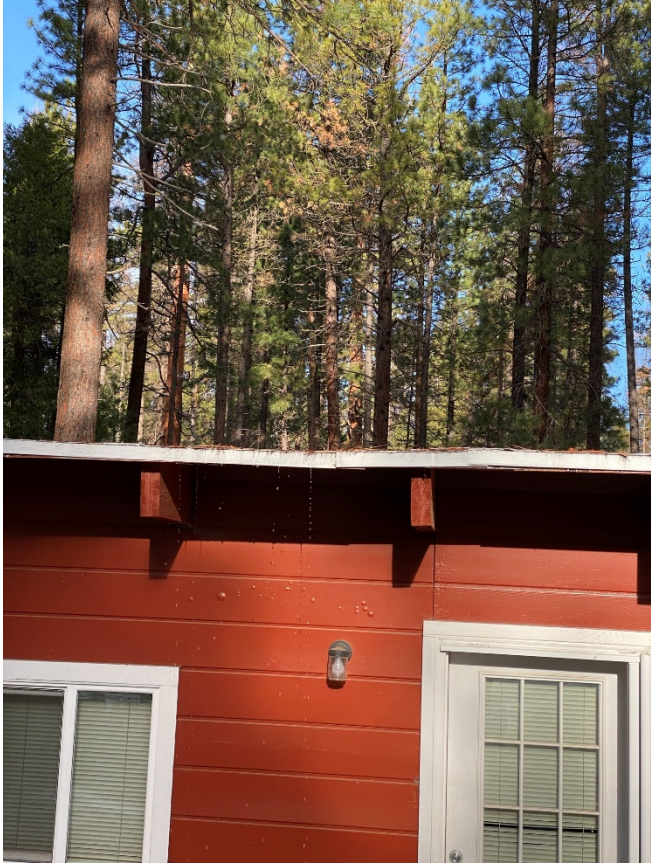
Damaged Roof Soffit

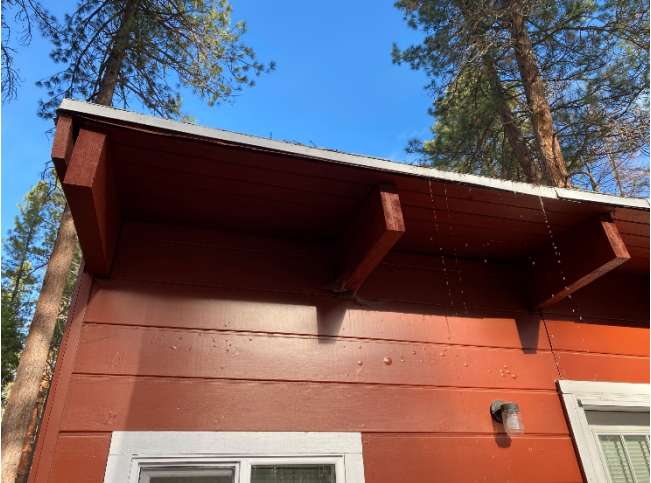
Damaged Roof Soffit

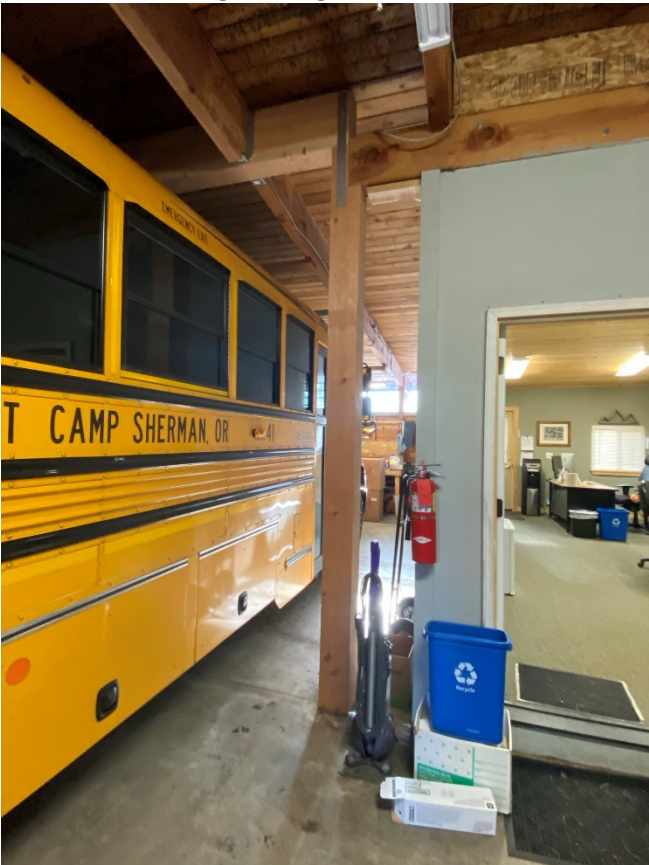
Creative Reframing for Larger Bus and Office

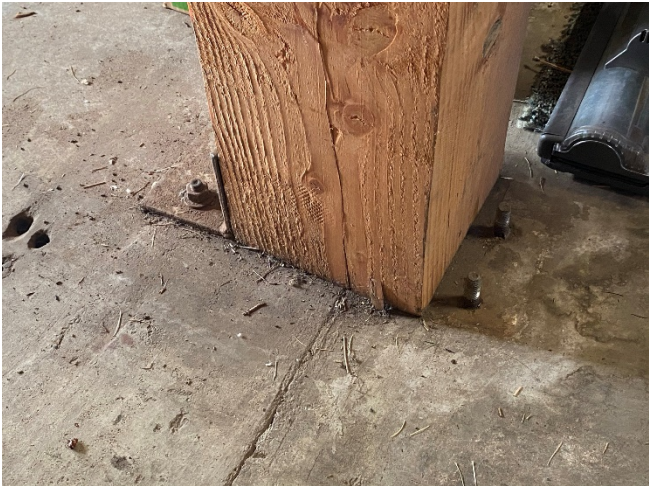
Inadequate Post Connection to Slab

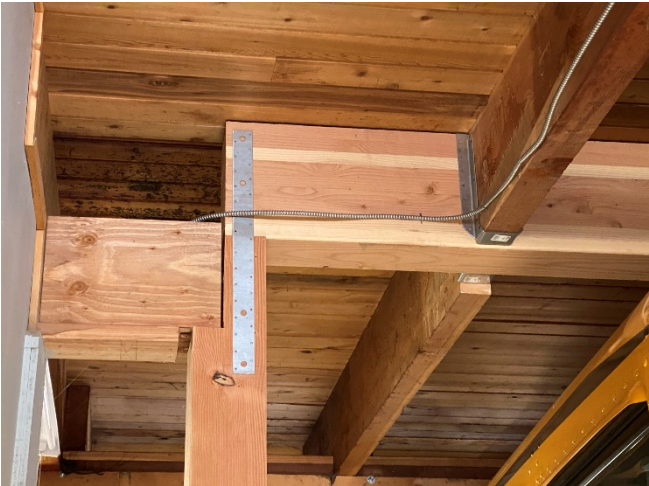
Inadequate Post to Beam Connection

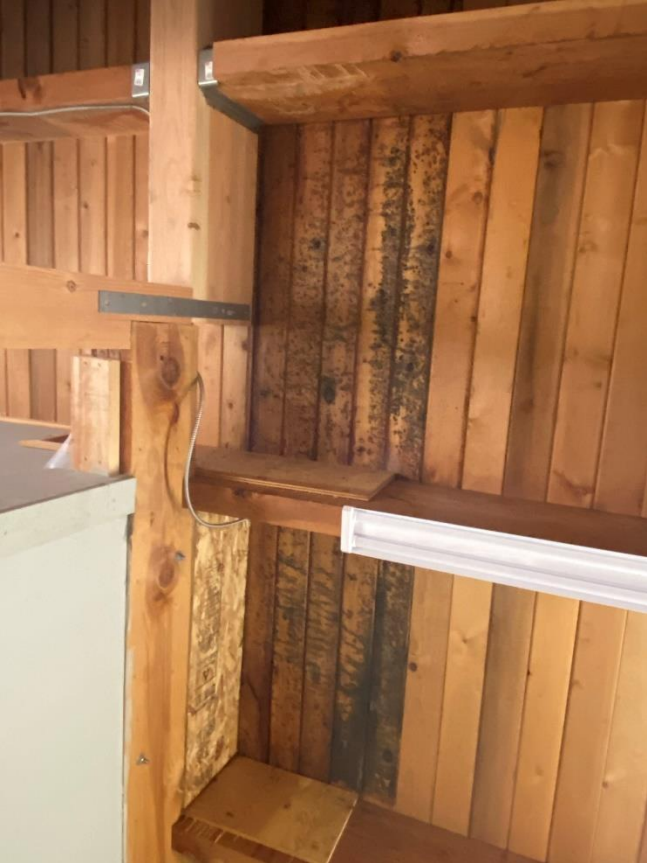
Evidence of Previous Roof Leak on Roof Decking

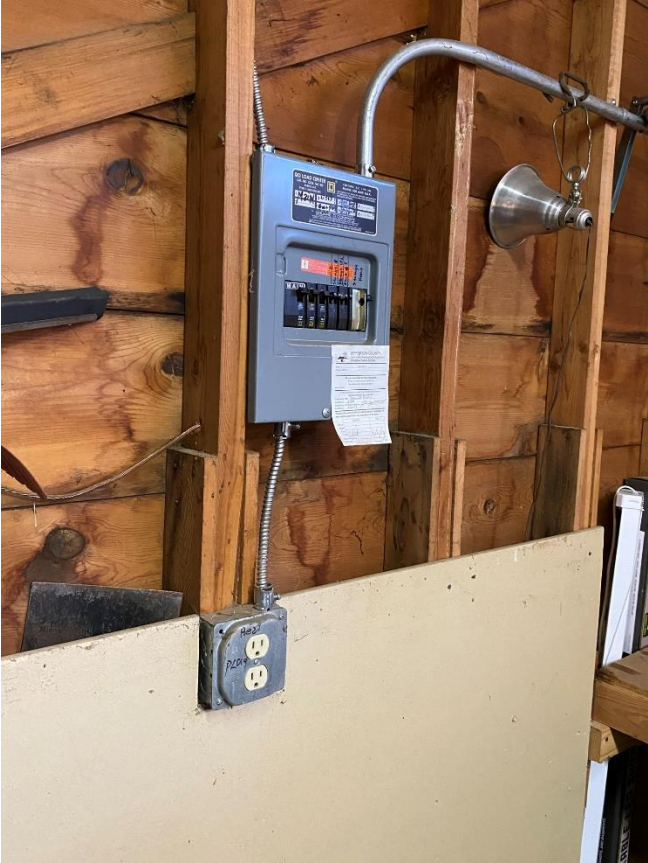
Potential Water Infiltration around Electrical Panel

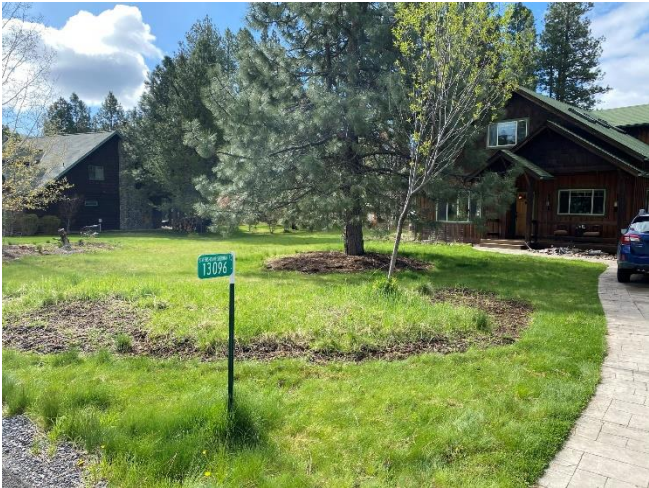
Landscape Damage

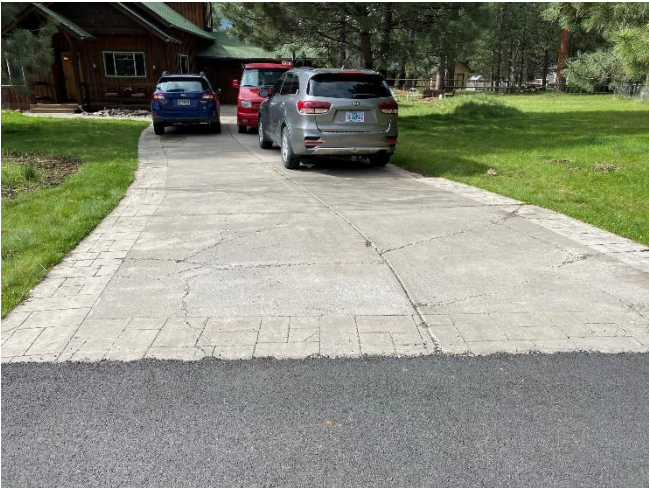
Cracked Driveway Surface

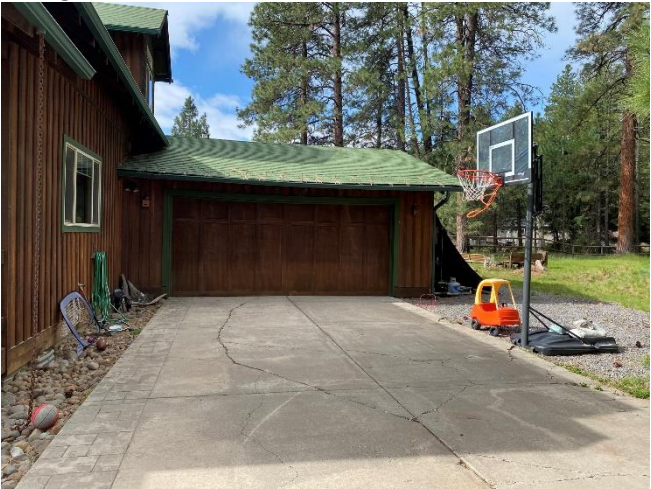
Cracked Driveway Surface & Sagging Roof over Garage Door

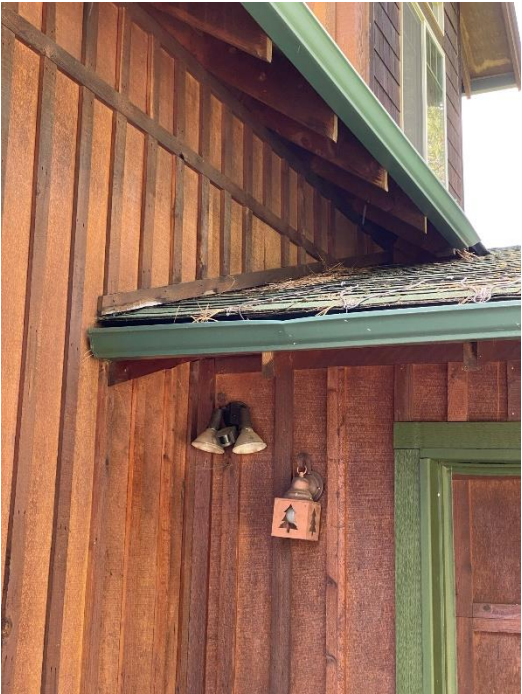
Gutter Damage Over Garage

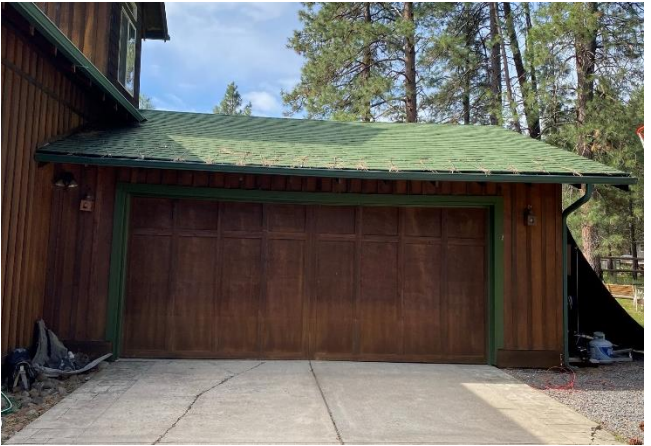
Sagging Roof over Garage Door

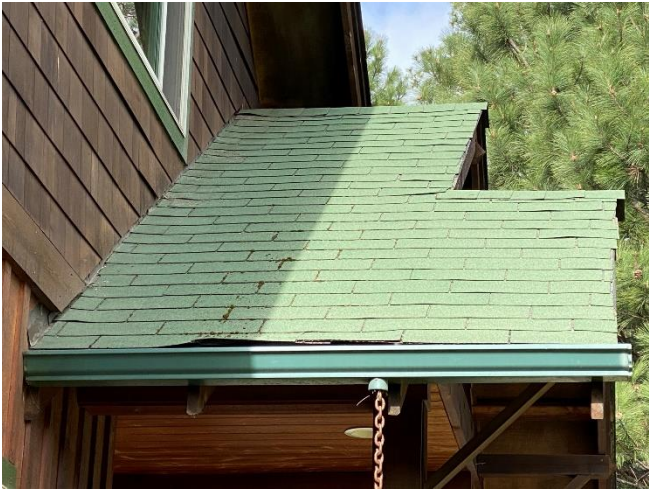
Damaged Roofing on Entry Canopy

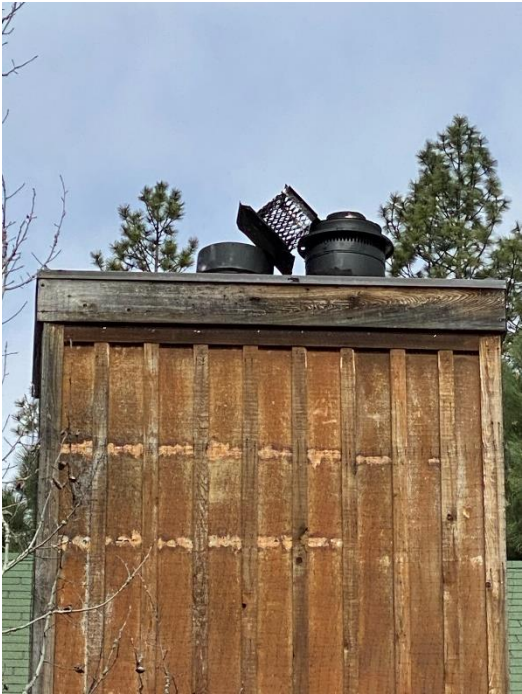
Chimney Spark Arrestor to be Secured

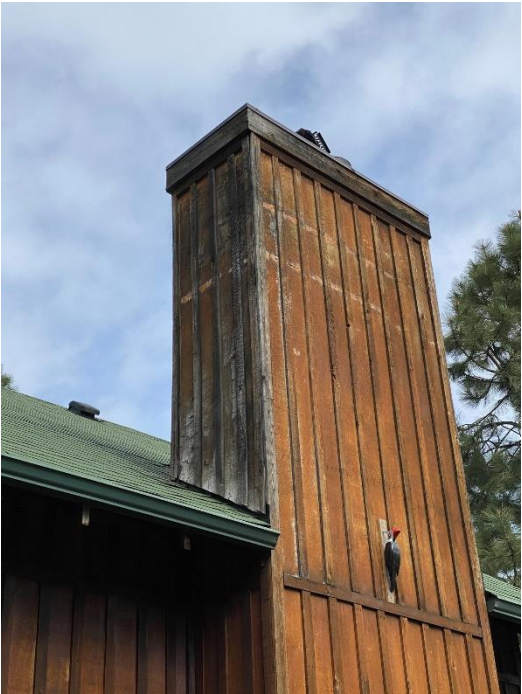
Siding Damage on Chimney

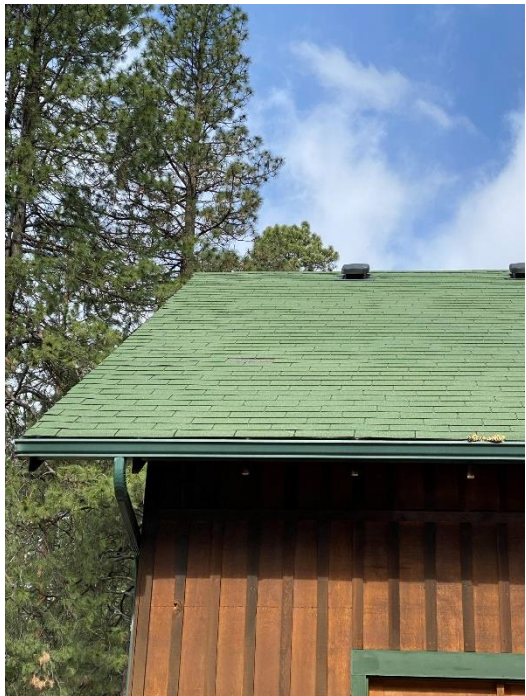
Roofing Damage

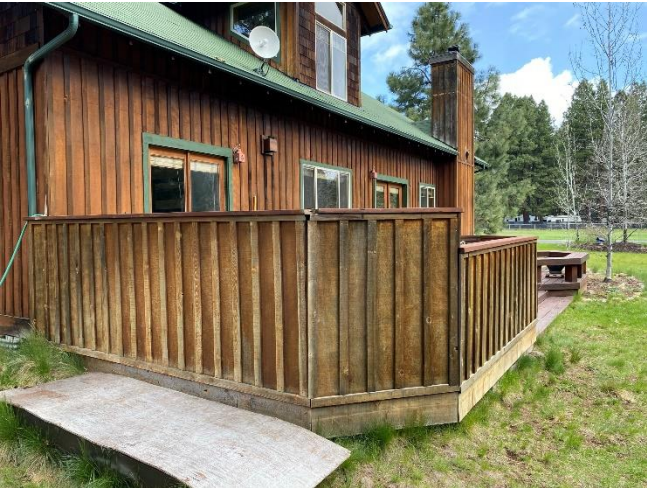
Deck Wall Enclosure Failure at Corner and Needs Re-Finish

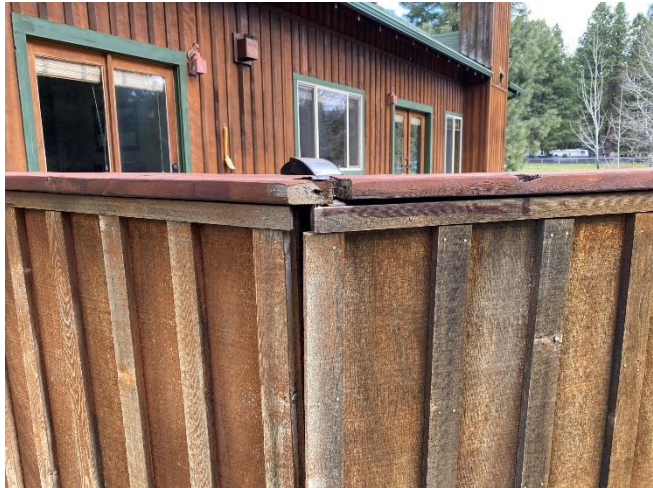
Closeup of Deck Wall Corner Failure

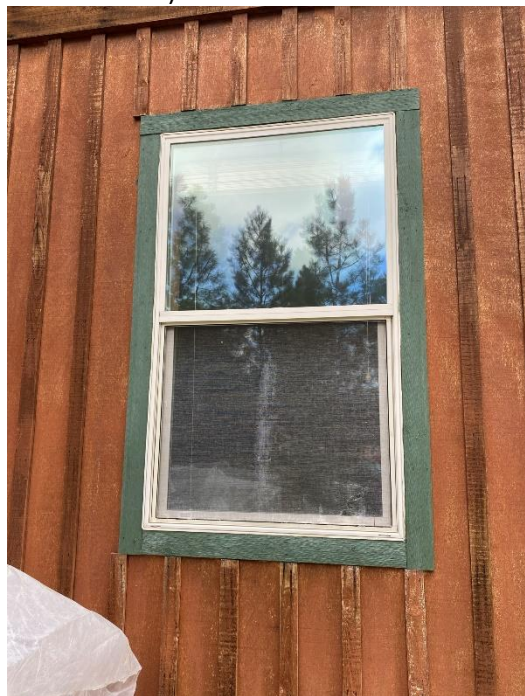
Torn Window Screen (typical of 2 first floor windows this elevation)

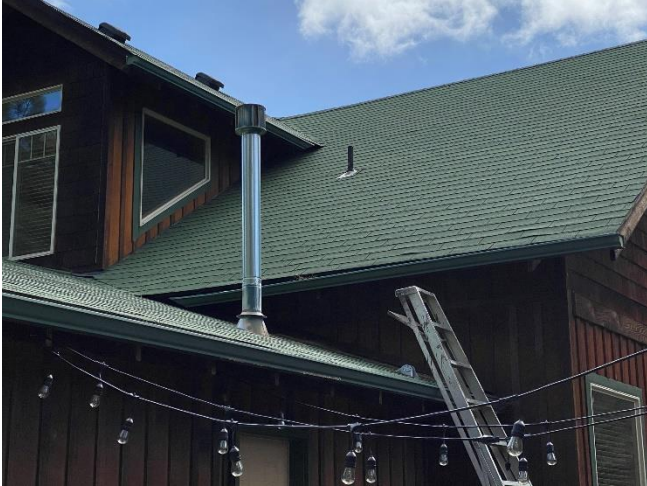
West Roof Damage along Roof Edge & Gutter Pulling off Fascia

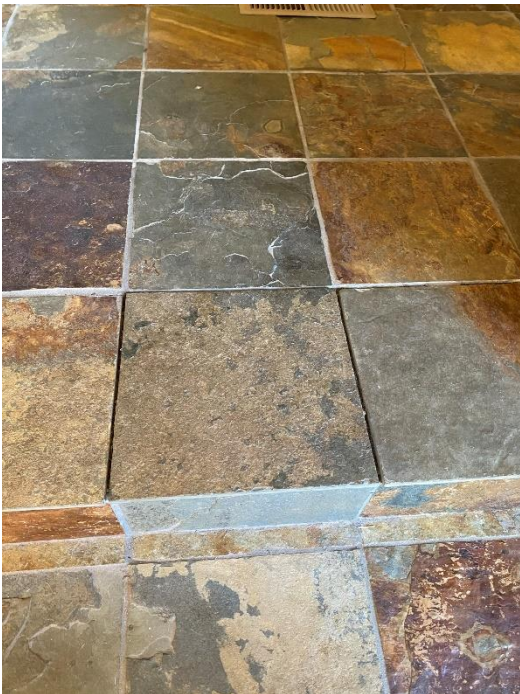
Entry Slate Tile Floor – Missing Mortar

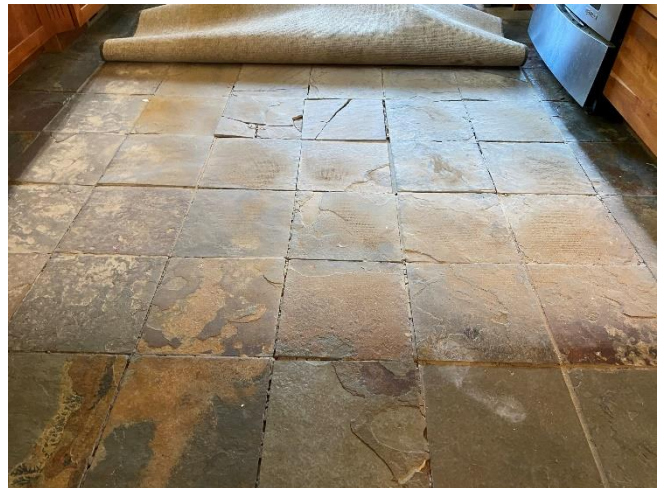
Kitchen Slate Tile Floor to be Replaced

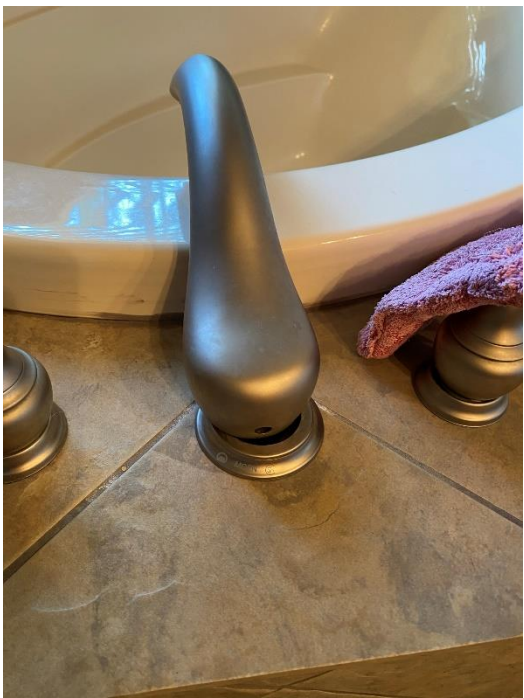
Master Bathroom Bathtub Faucet Unsecure

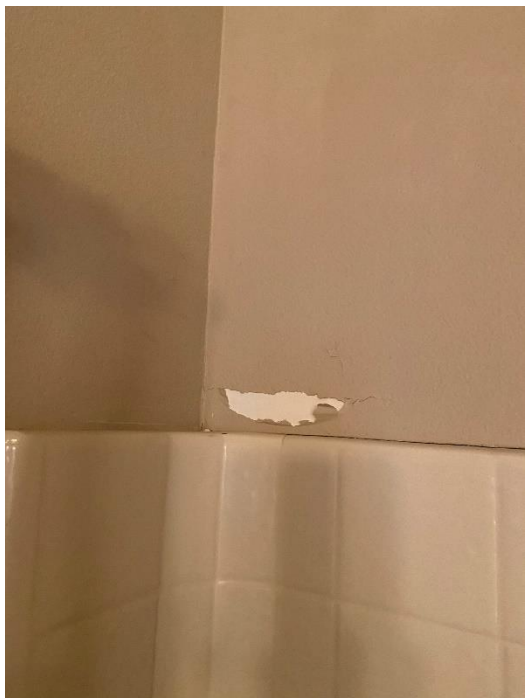
Master Bathroom Shower Drywall Damage

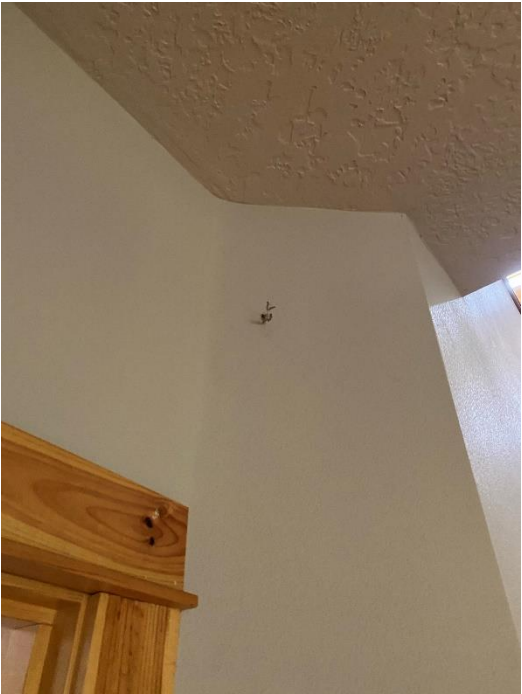
Hallway Drywall Random Wire

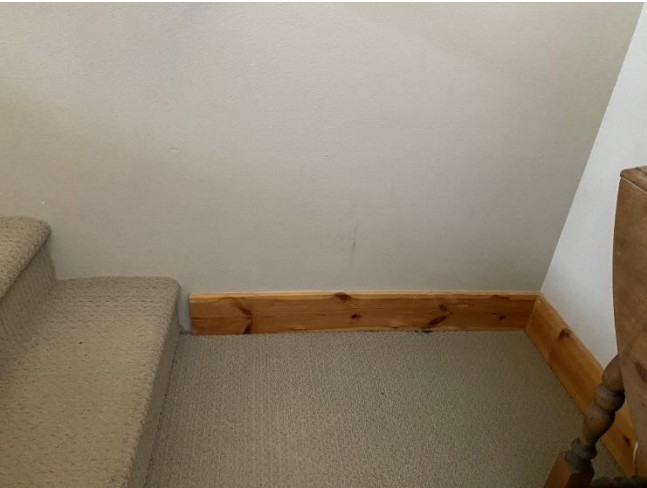
Stairway Baseboard Missing at Stairs

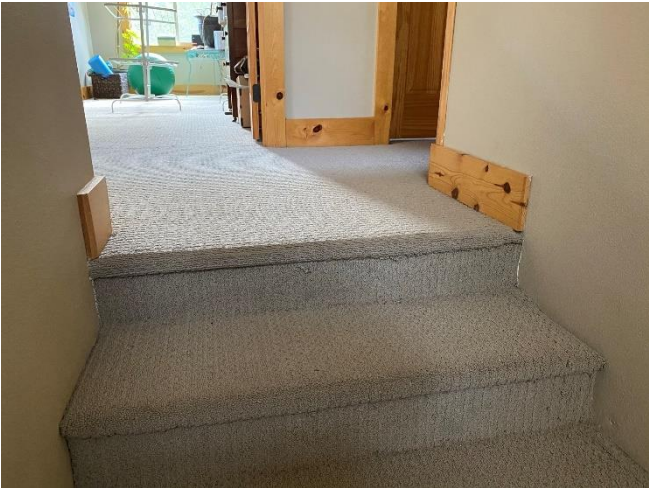
Stairway Baseboard Missing at Stairs

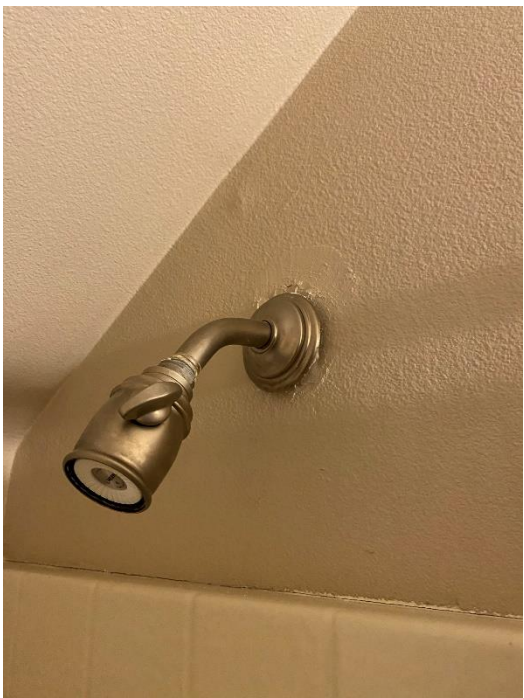
Upstairs Bathroom Faucet Not Secure to Wall

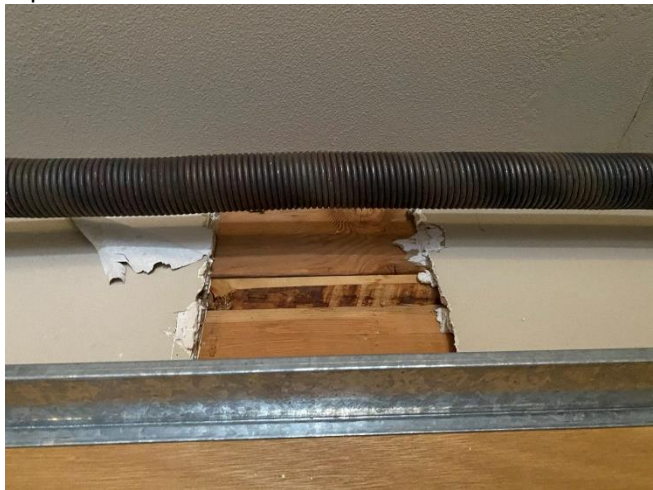
Garage Door Opening Beam Investigation – to be repaired

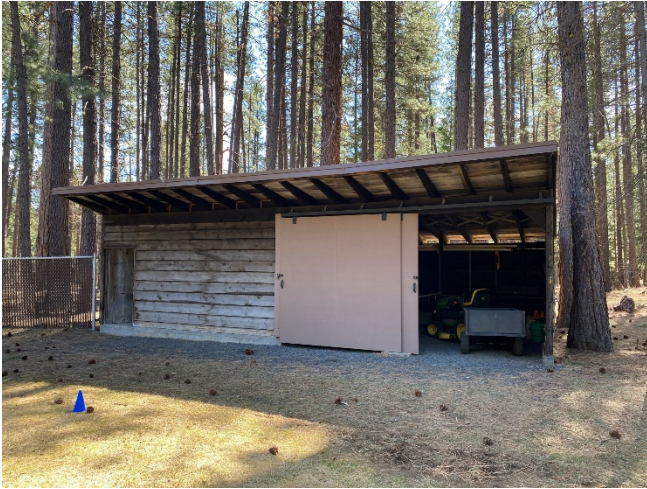
Northern (front) Elevation

- Siding in need of stain

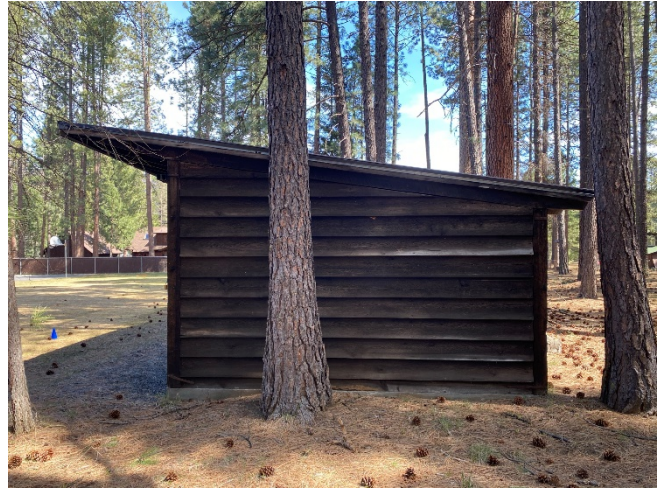
Western (side) Elevation

- Siding cupping

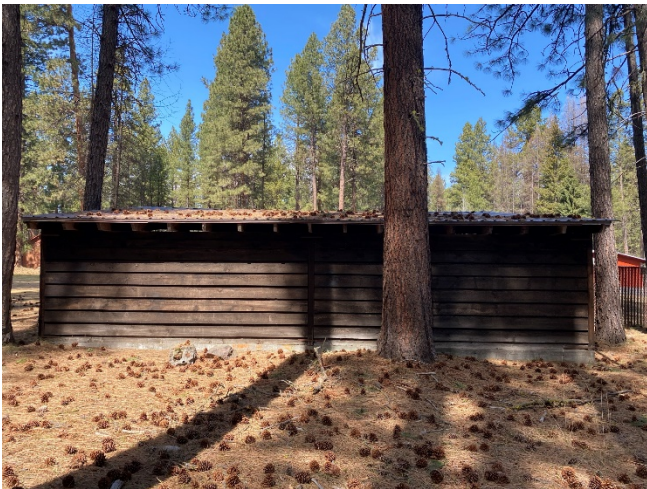
Southern (back) Elevation

- Tree close to foundation

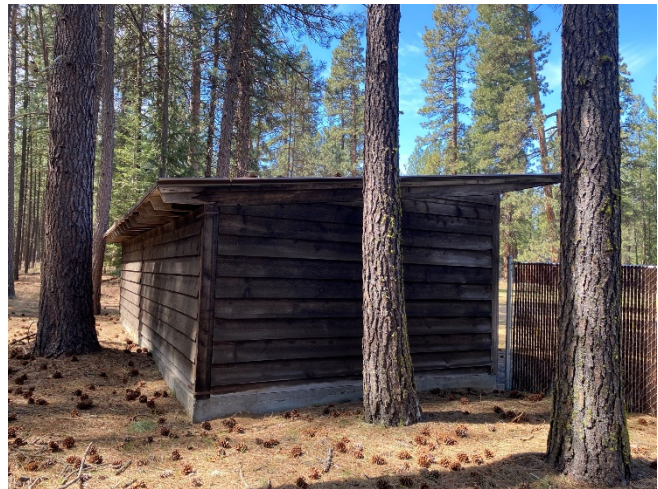
Eastern (side) Elevation

- Siding in need of stain

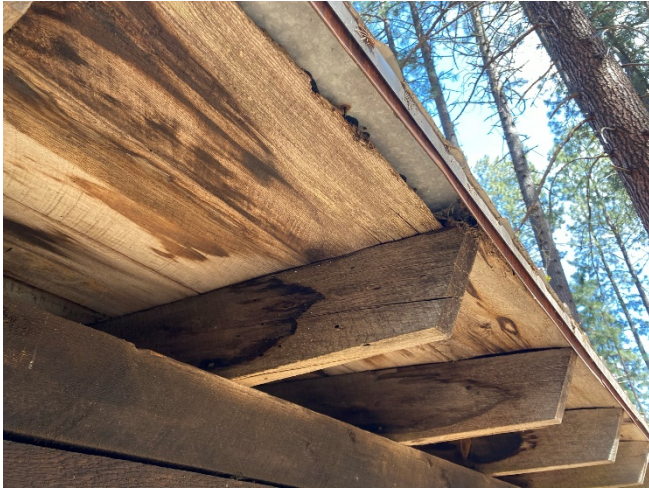
Roof Overhang on Rear Elevation

- Deteriorated board to be replaced

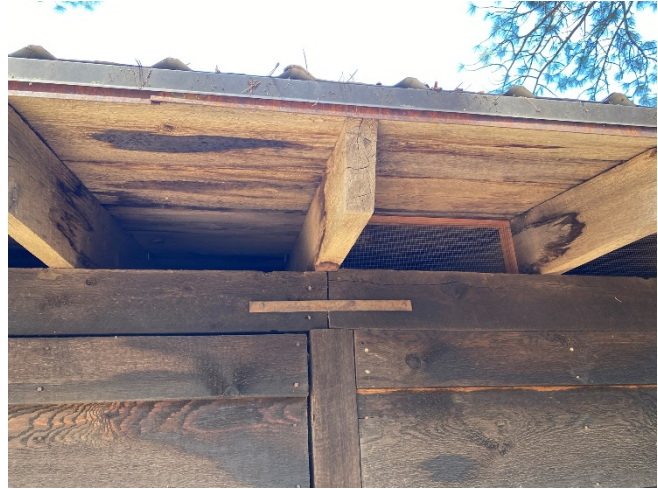
Building Connection on Rear Elevation at Roof

- Metal strapping connection to be reinforced

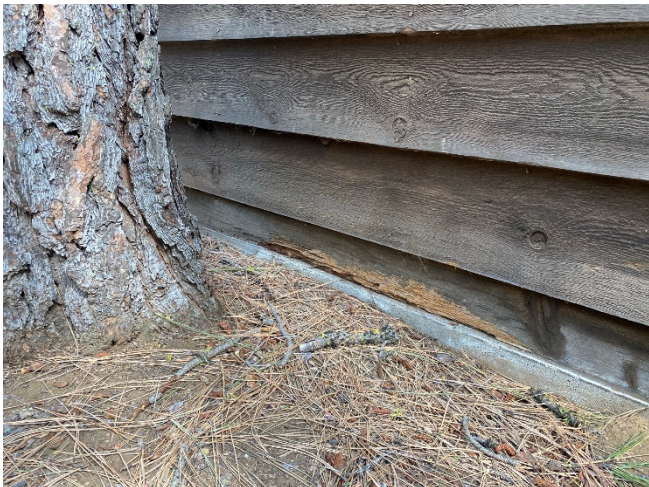
Siding on Rear Elevation

- Close to tree and visible termite damage

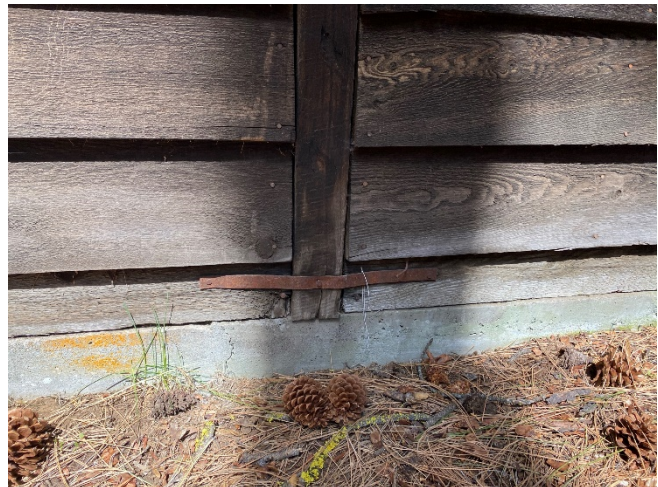
Building Connection on Rear Elevation at Foundation

- Metal strapping connection to be reinforced
