Long-Range Planning Meeting Presentations and Minutes

Facility Condition Assessment Report

**Black Butte School District
Camp Sherman, Oregon
Spring 2022**

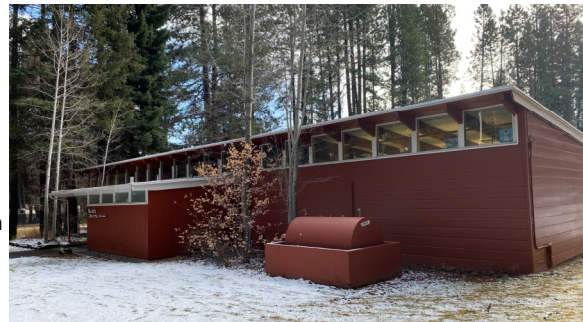
Main Building Summary

- Originally built in 1951
- Safety and Security Concerns
 - Lack of passive supervision
 - No entry vestibule
 - Offices in the rear
 - Unfenced grounds
- Overall, the exterior of the building is in good condition
 - Exterior windows
 - Exterior siding
- Membrane roof should be replaced
- Flooring is showing wear
- Mechanical and Electrical systems reaching end serviceable of life
- Select site improvements are needed
- Minimal ADA concerns

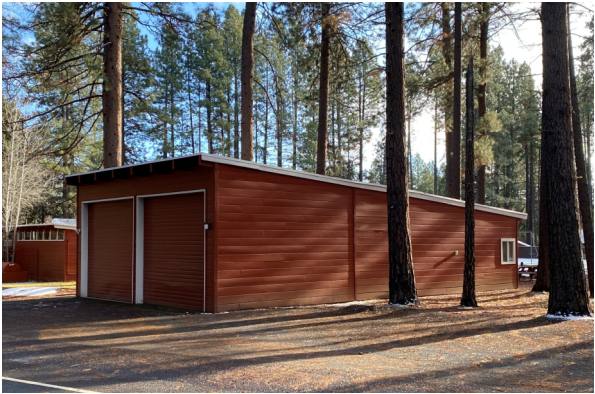
Bus Barn Summary

- Date of construction - unknown
- Safety and Security Concerns
 - Single pane windows
- Overall, the exterior of the building is in good condition
 - Exterior siding
 - Membrane roof
- Membrane roof should be replaced
- Some electrical systems reaching end serviceable of life

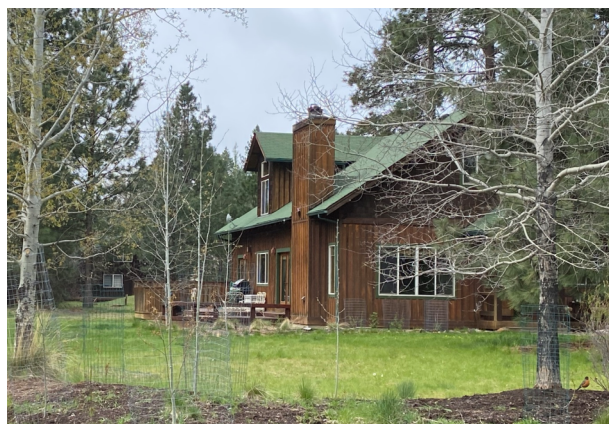
Summer Lane Residence Summary

- Built in 1951
- Safety and Security Concerns
 - No major concerns
- Overall, the building is in good condition
- Some aesthetic improvements needed

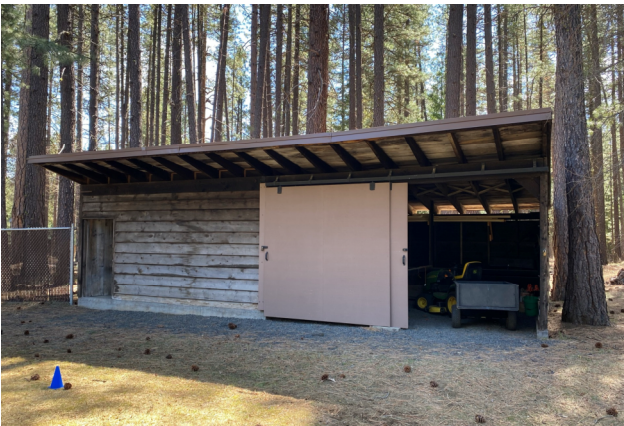
Storage Shed Summary

- Date of construction is unknown
- No structural concerns
- No lighting
- There is no paved path to building

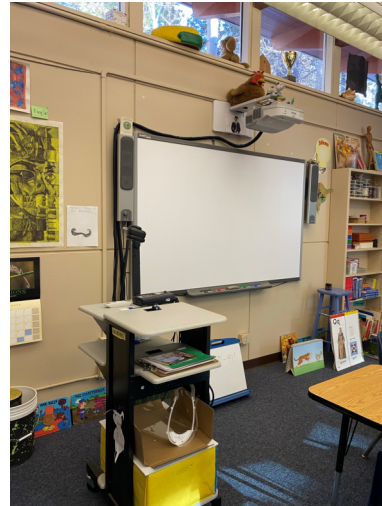
TECHNOLOGY

- **Data Network** – New internet provider. Could use more hard-wired locations, especially in MPR. Server is not enclosed, and Chromebooks are not secured.
- **Power Distribution** – MPR doesn't have great power distribution. Not enough outlets for Chromebooks.
- **Audio Enhancement** – Don't have voice amplification system
- **Video/Interactive Technology** – One classroom has hard-wired speakers. Software is outdated on smartboards, and they are used solely as projectors.
- **Fire and Life Safety** – No fire alarm system

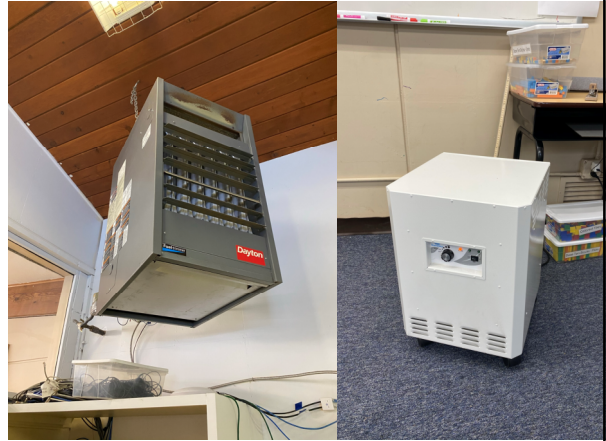
Learning Environment

- **HVAC** – No AC. Heater in MPR is loud and doesn't work well. Heat works okay in classrooms. There is no mechanical ventilation.
- **Natural Ventilation** – No operable windows. Have to open doors which is a security concern.
- **Indoor Air Quality** – Air quality is poor. Portable air purifiers are used.
- **Day-Lighting** – Great natural daylighting in classrooms. Lack of natural light in MPR.
- **Acoustics** – Acoustics are a challenge in MPR. Acoustics aren't great in classrooms. No space for private conversations which impacts operations.
- **Accessibility** – The facility is generally accessible but has some threshold challenges and non-accessible sinks
