Black Butte School District

Facility Condition Assessment Report

Camp Sherman, Oregon

Assessment: December 2020

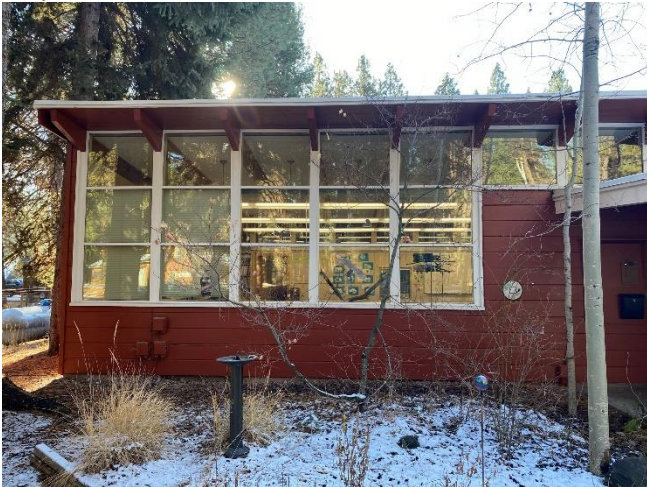
Inoperable Windows

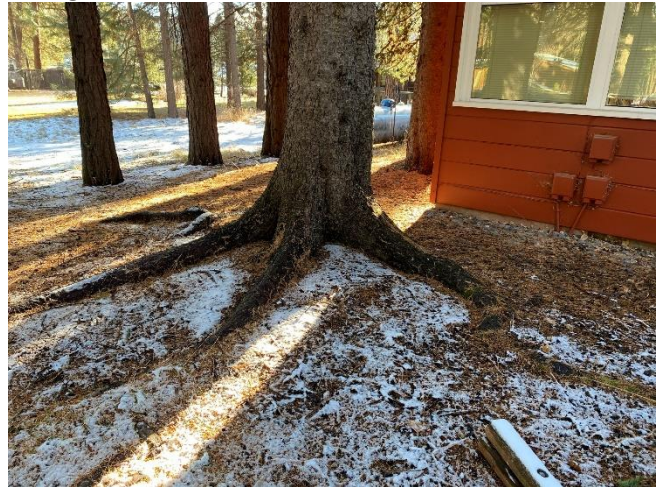
Overgrown Tree Roots close to Structure

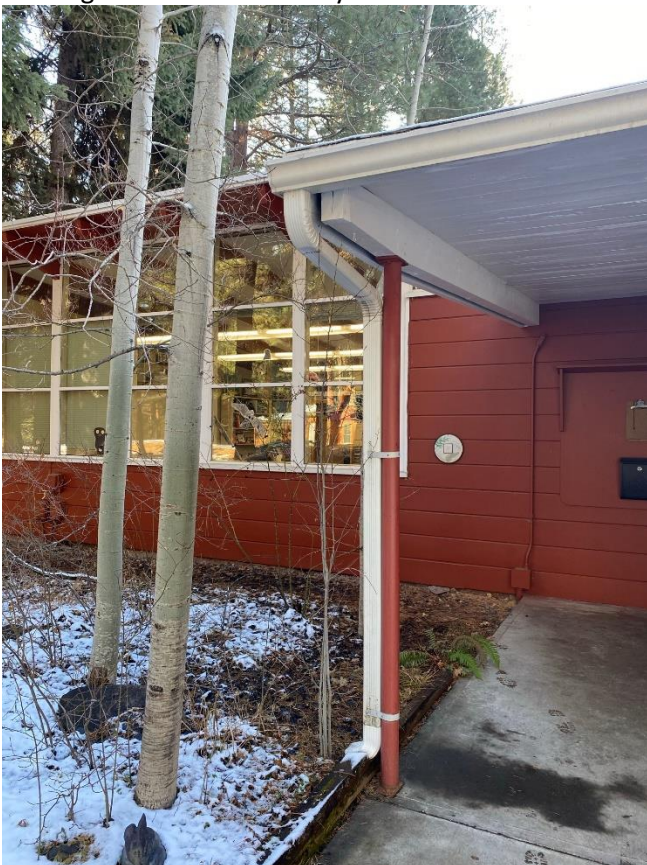
Drainage Issue at Front Entry

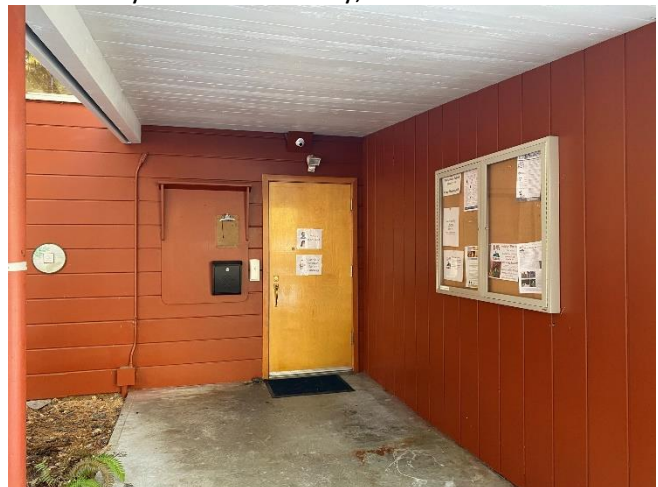
Front Entry With No Visibility, Non ADA Hardware

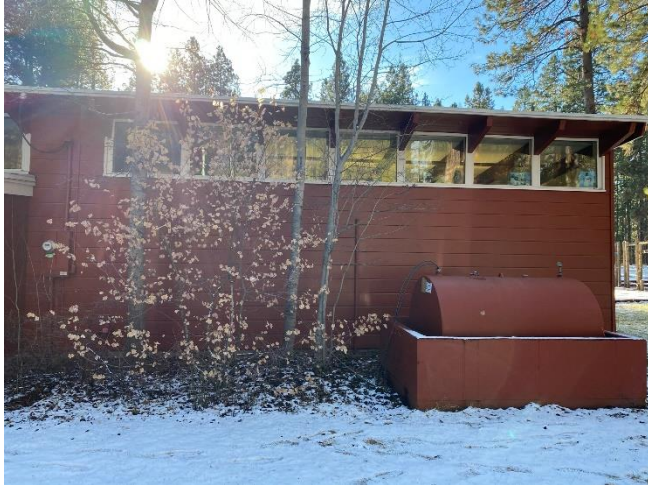
Single Pane Windows, Propane Tank Close to Building

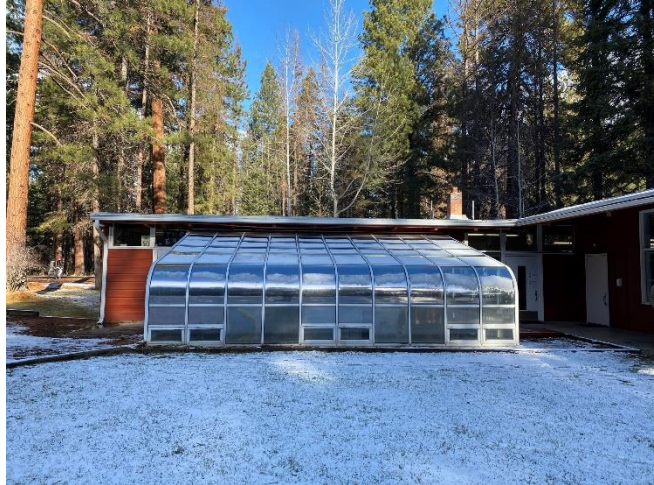
Greenhouse Used as Classroom

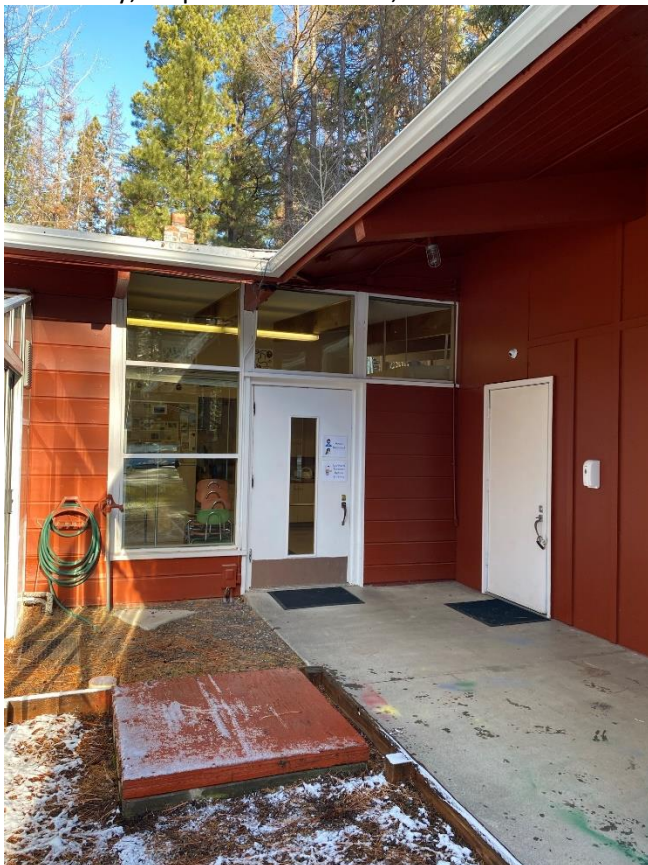
Back Entry, Inoperable Windows, Non ADA Hardware

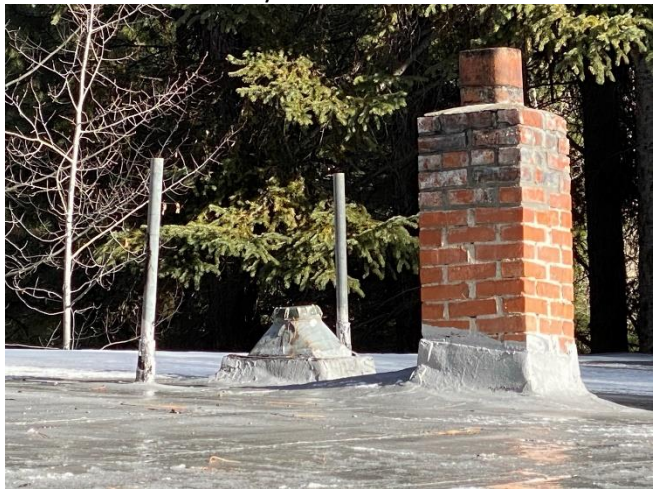
Unreinforced Chimney

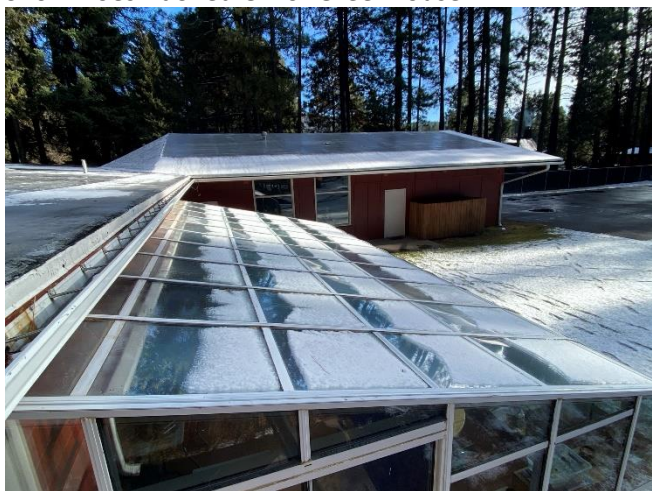
Snow Doesn't Shed Off of Greenhouse

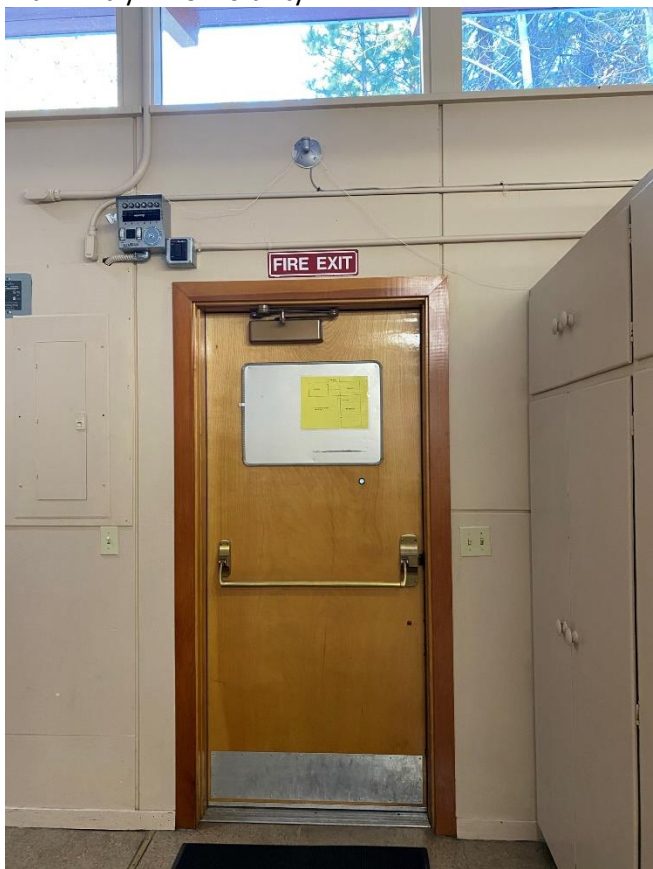
Main Entry – No Visibility

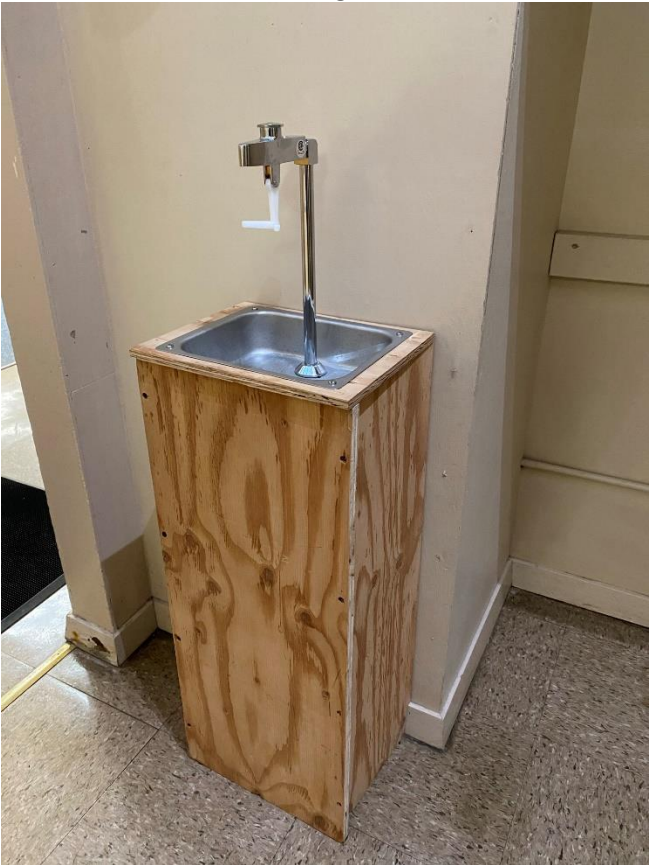
Non-ADA Accessible Drinking Fountain

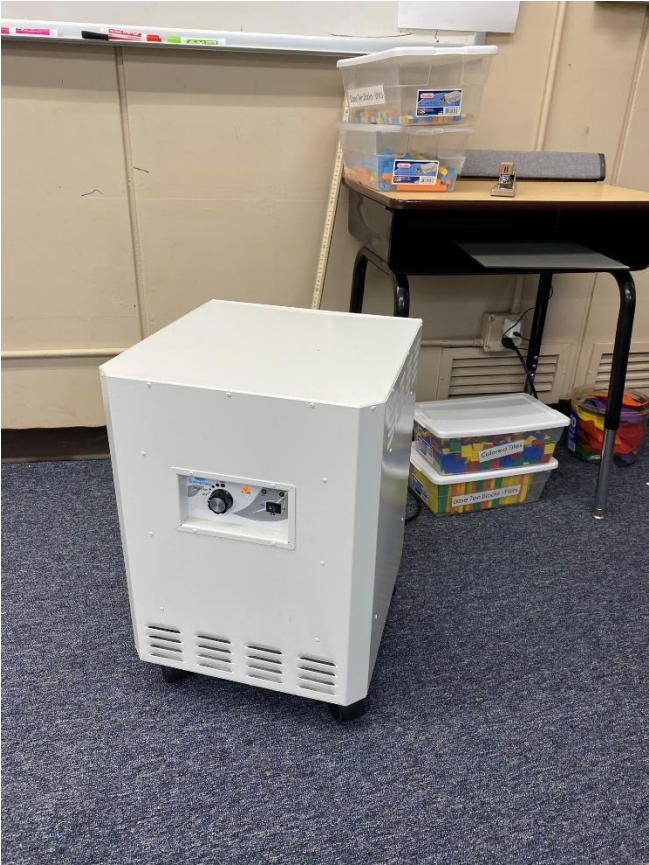
Portable Air Purifier

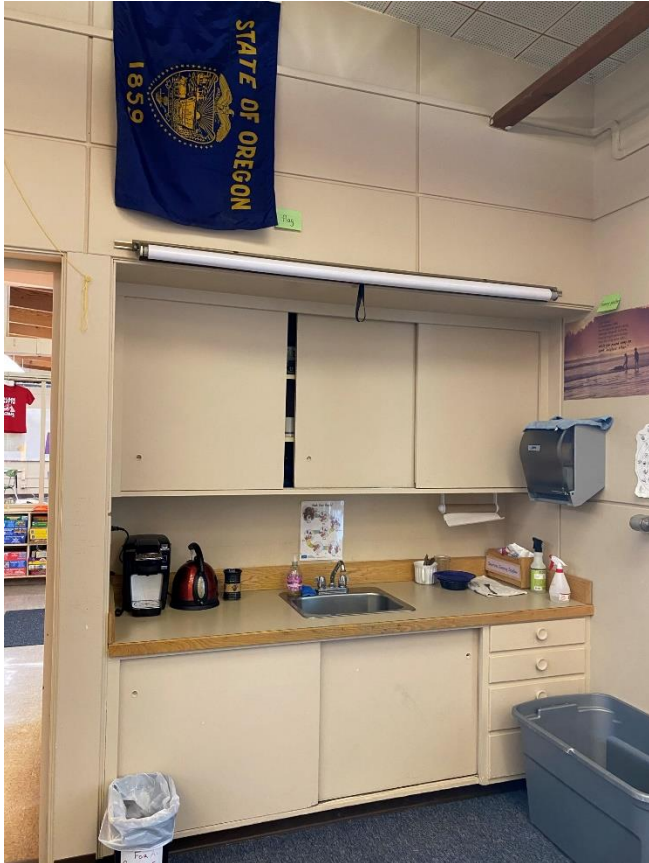
Non-ADA Accessible Classroom Sink

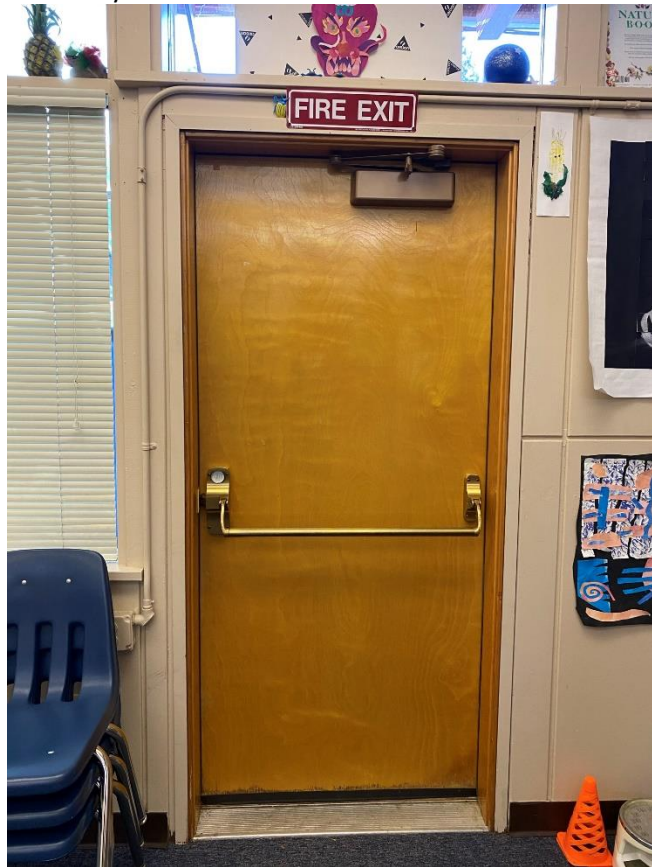
No Ability to Lock Door from Inside

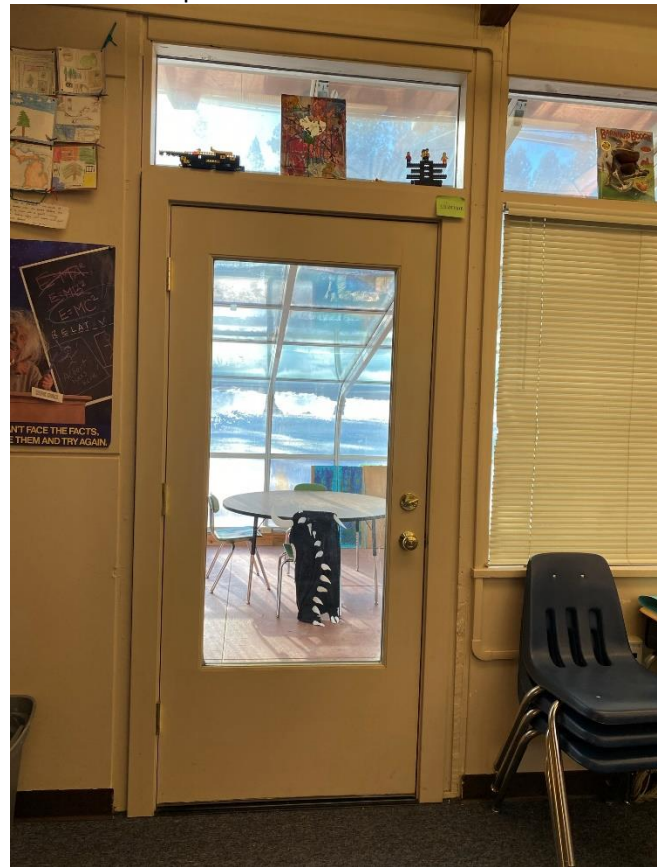
Non-ADA Compliant Door Hardware

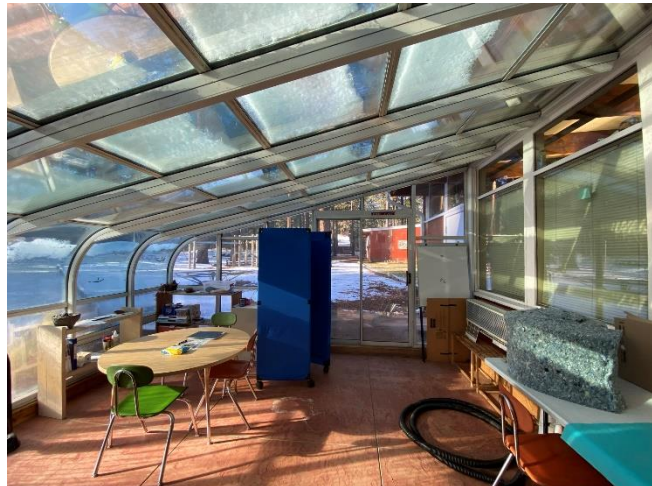
Greenhouse Used as Classroom

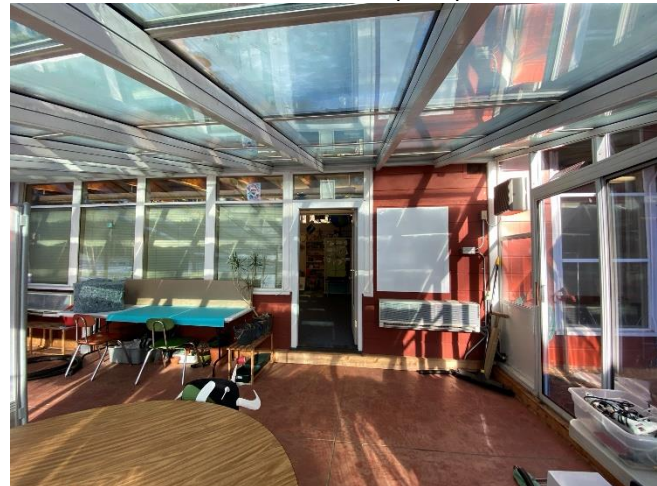
Greenhouse Used as Classroom (cont).

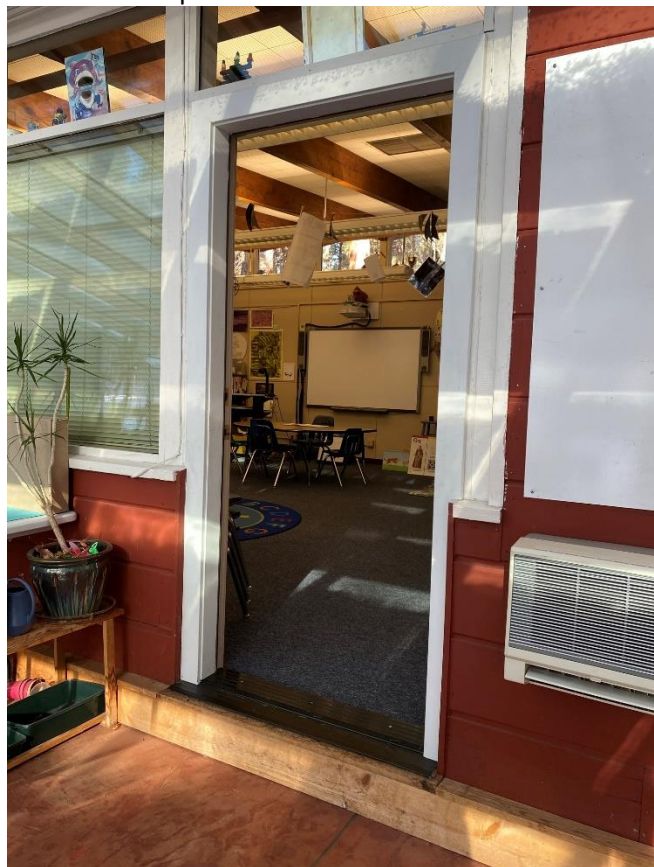
Non-ADA Compliant Door Access

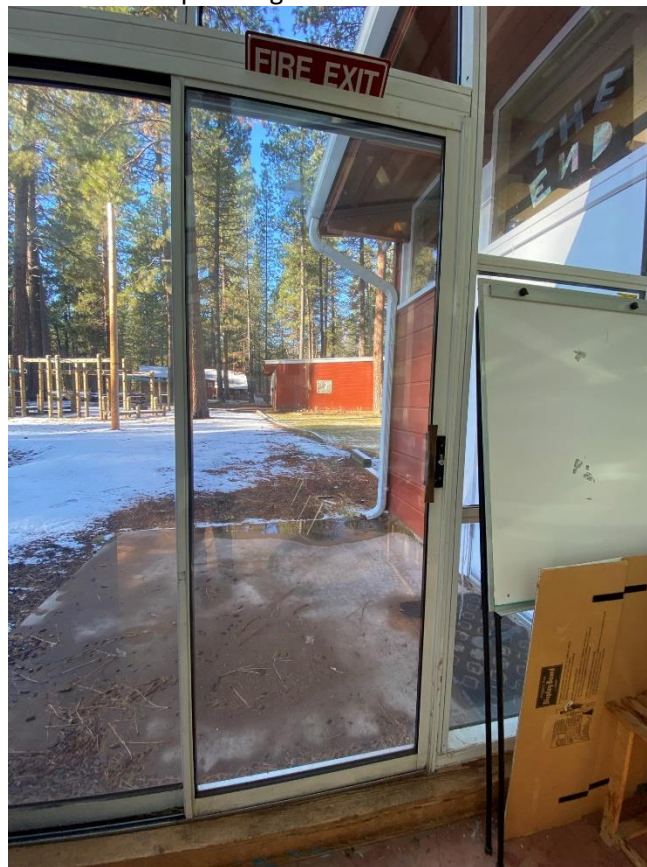
Non-ADA Compliant Egress Door

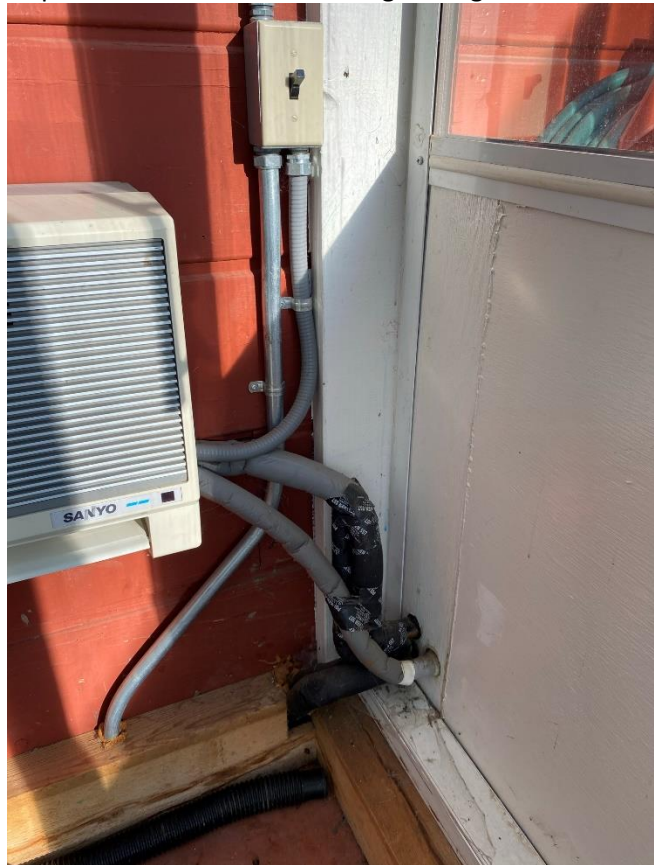
Unprotected Access to Plumbing-Wiring

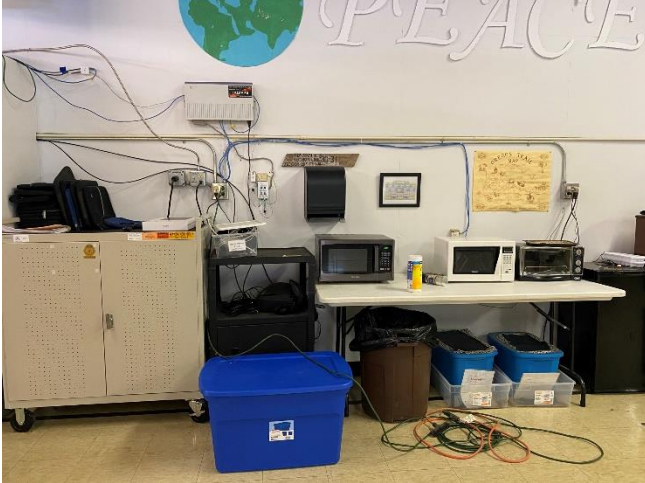
IT Area, Staff – Main “Kitchen” area. No food service provided to student

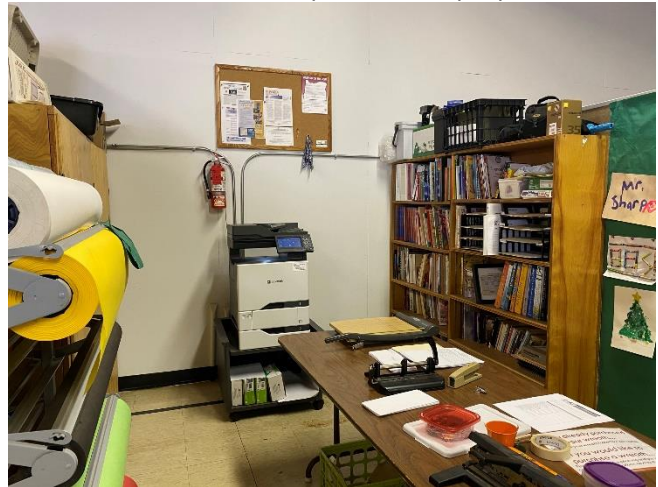
Staff Workroom Area – Open to multipurpose room

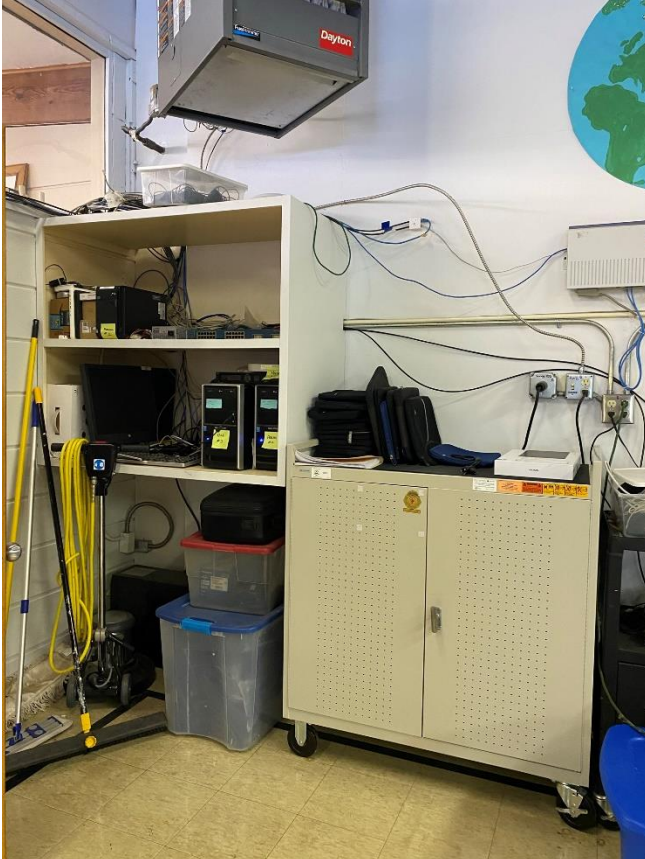
IT Area Unrestricted Access

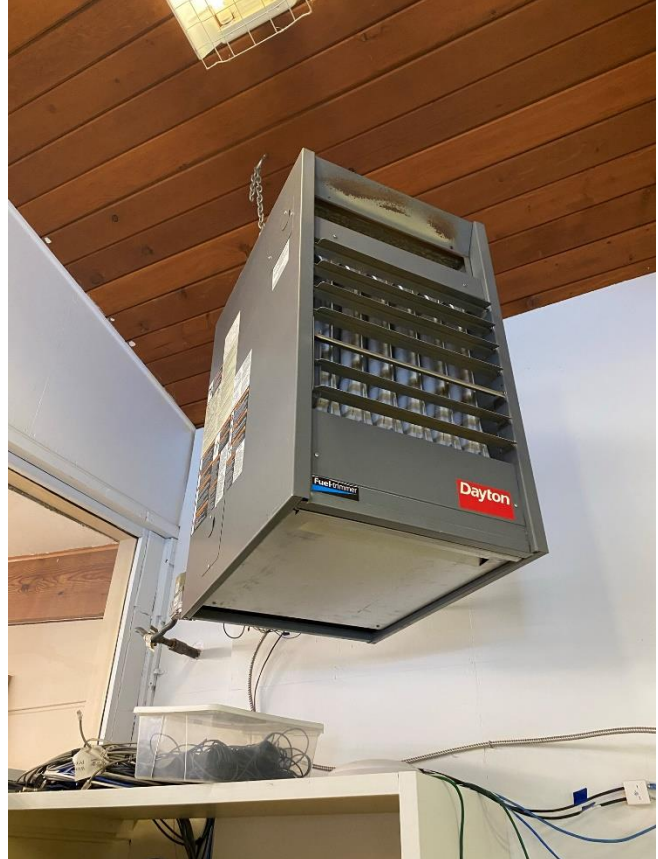
Multipurpose Room Heating System

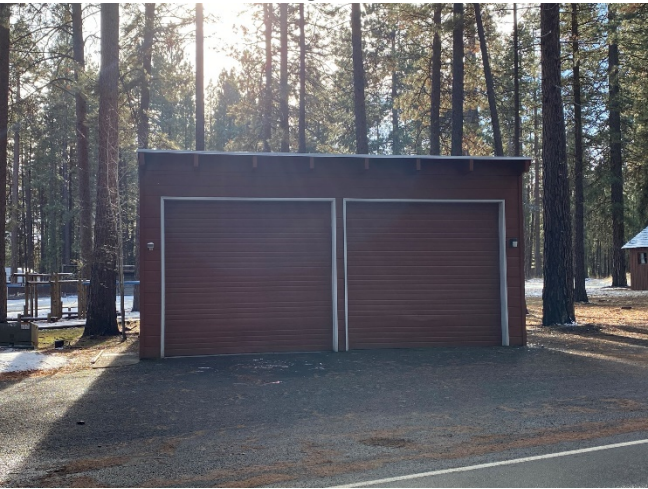
Front Elevation with Garage Doors

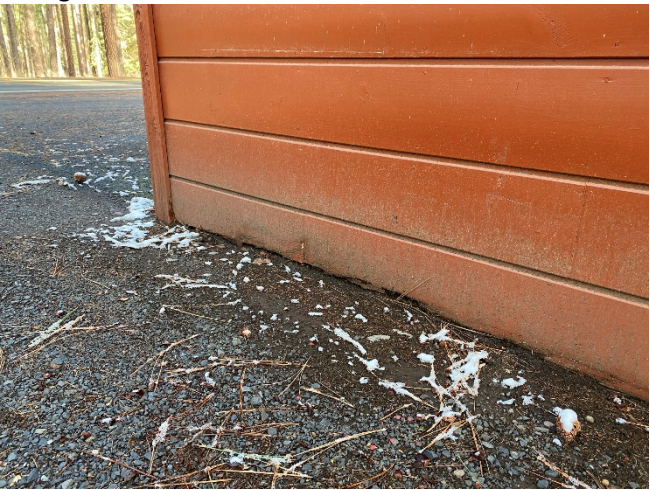
Siding Below Grade

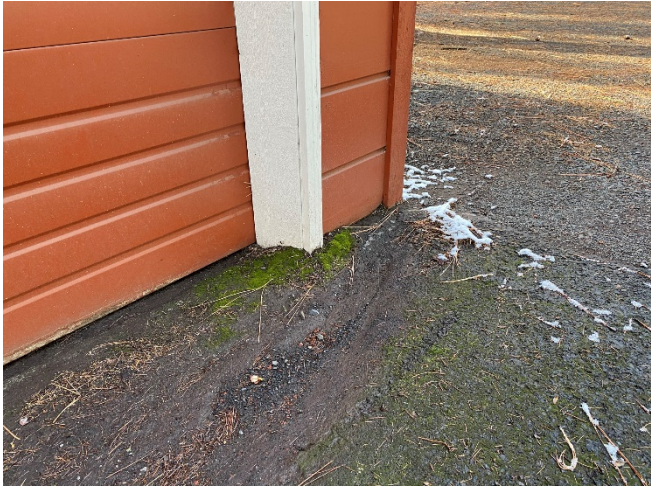
Sididng and Posts within Dirt + Drainage Issue

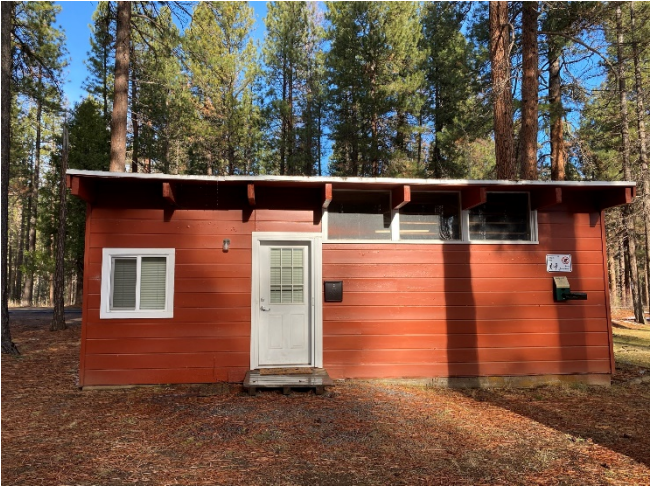
Back Elevation with Windows & Door

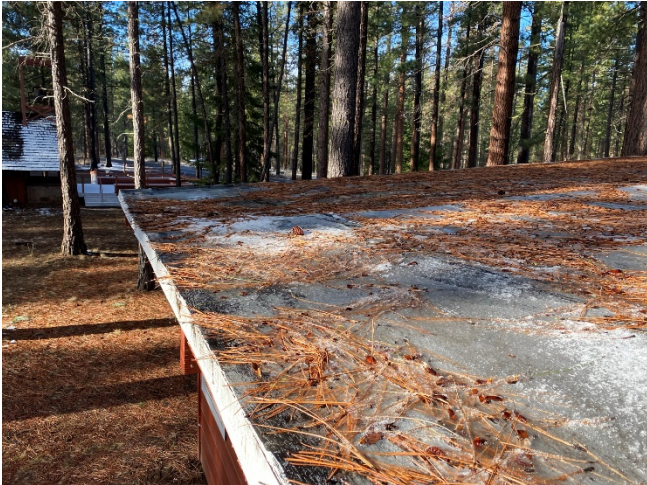
Ice & Debris in Internal Gutter

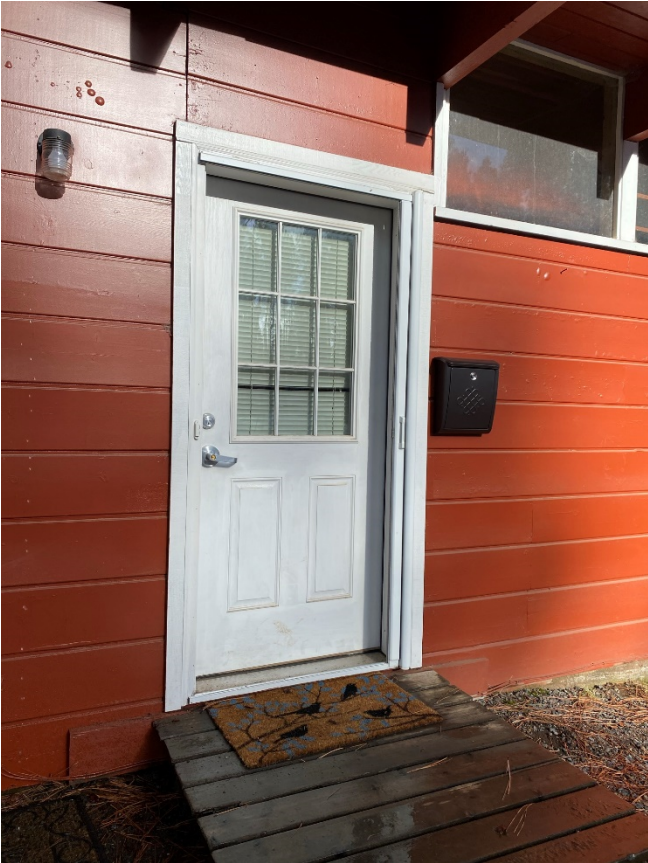
Rear Metal Door

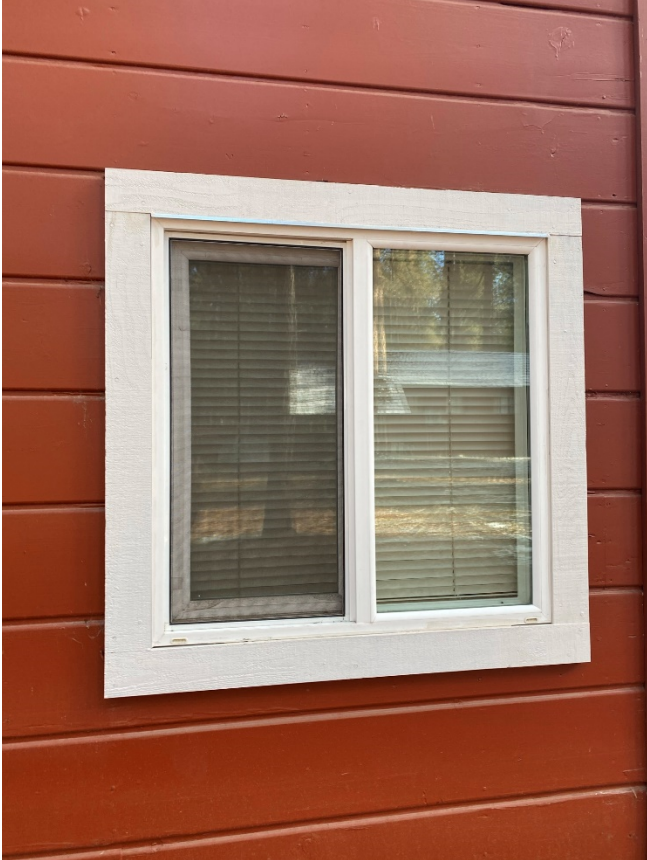
One of Two Vinyl Sliding Windows

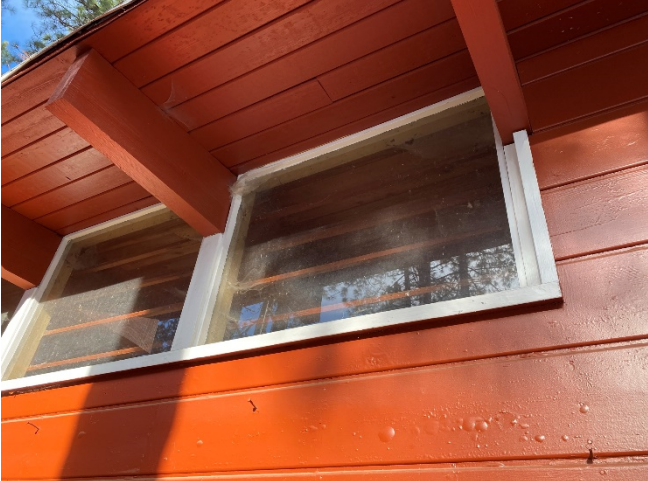
Two of Three Fixed Single Pane Wood Windows

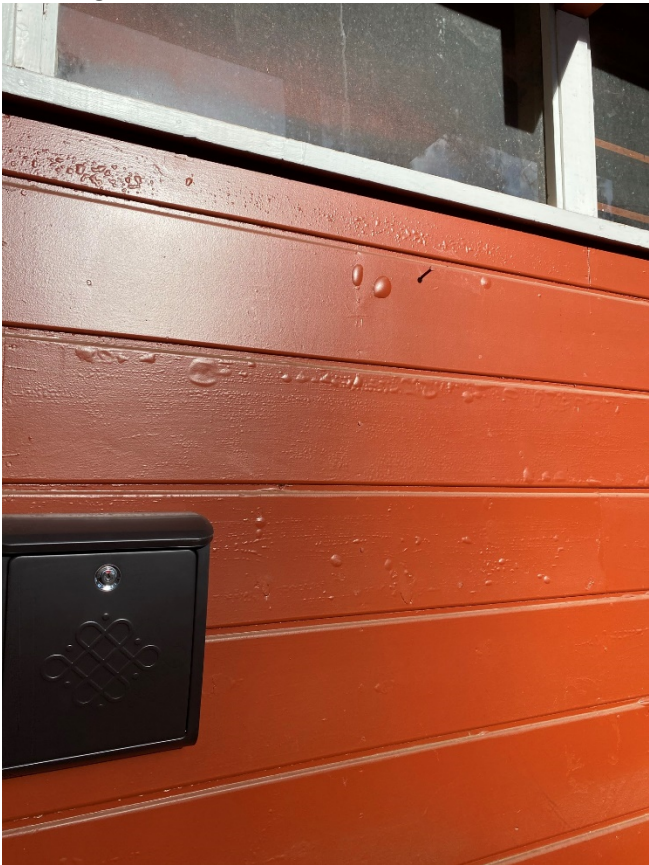
Bubbling Paint Finish

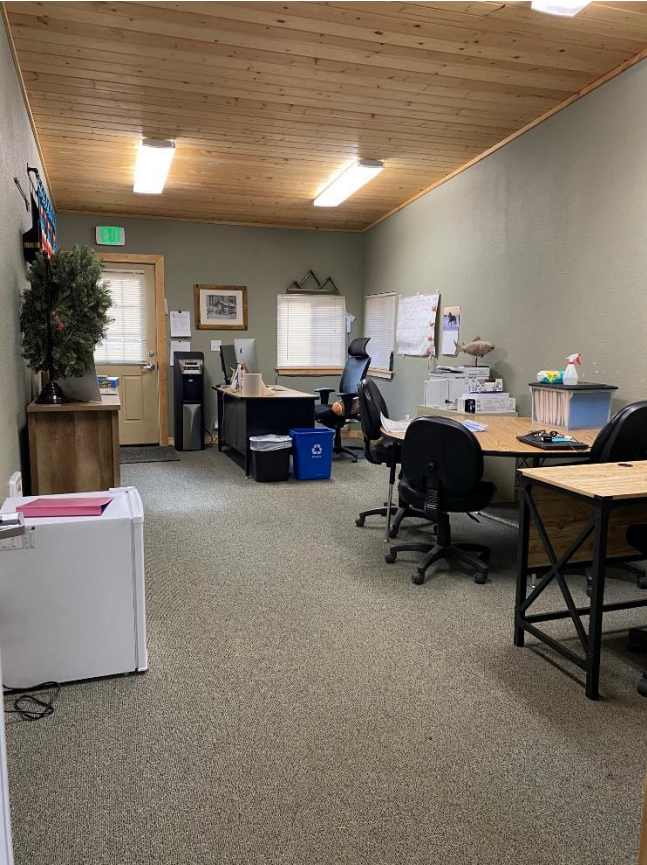
Office Recently Refinished

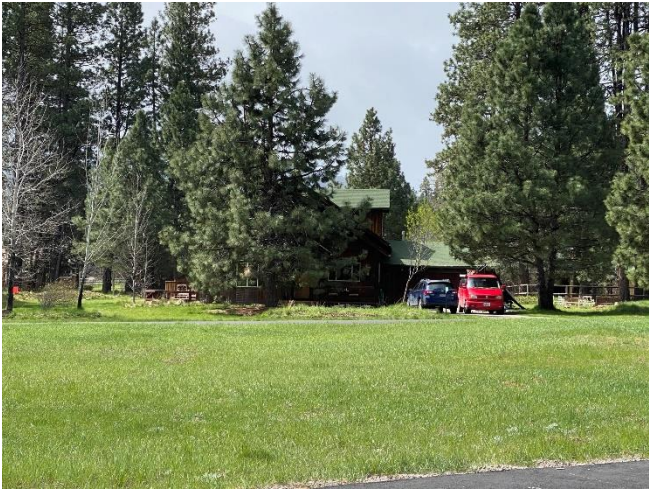
Overall Property View – Trees Block View of Structure

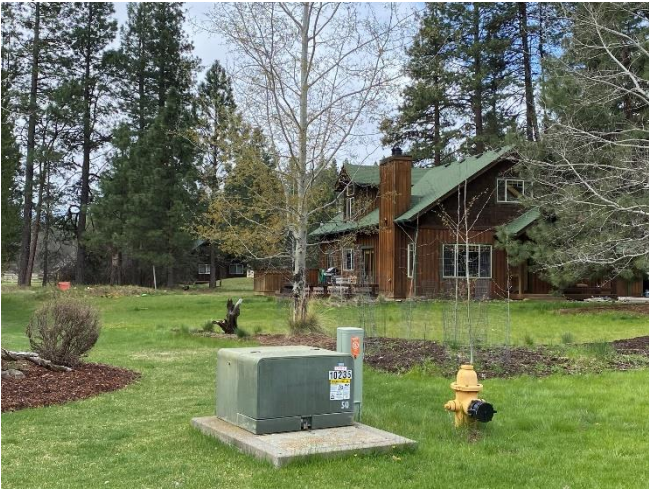
Overall Property View – Existing Landscape is Natural, Septic Tank Buried in this Side Yard

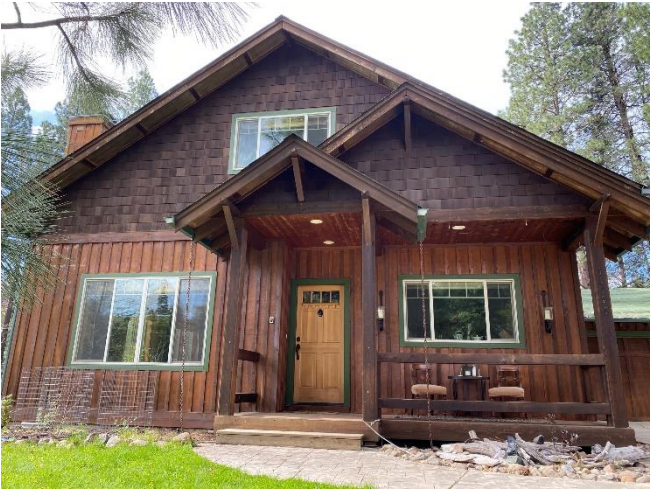
North (Front) Elevation of Existing Structure

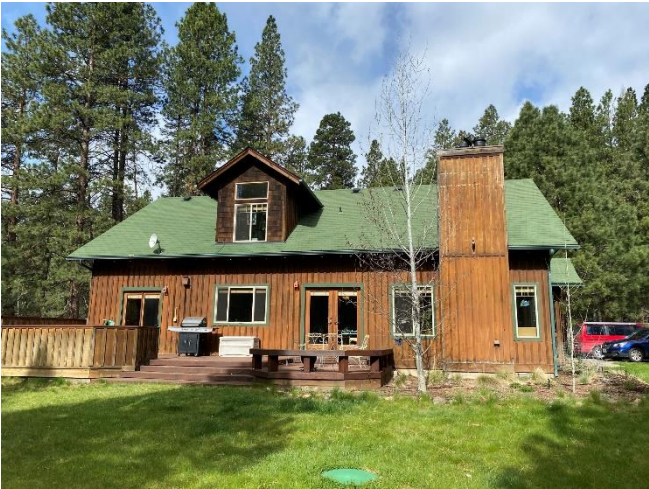
West (Side) Elevation of Residence

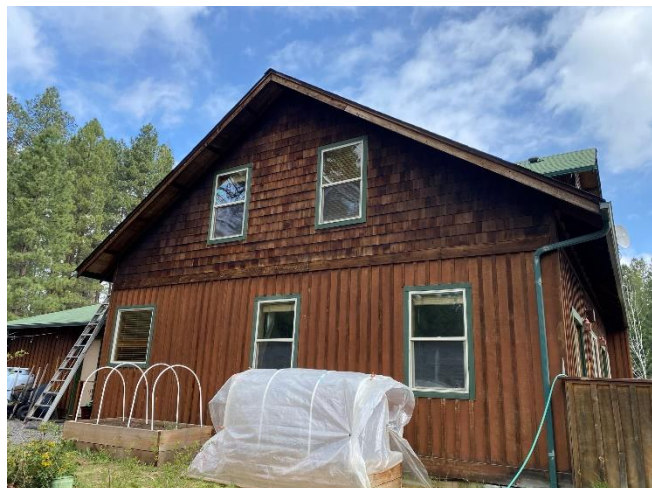
South (Back) Elevation of Residence

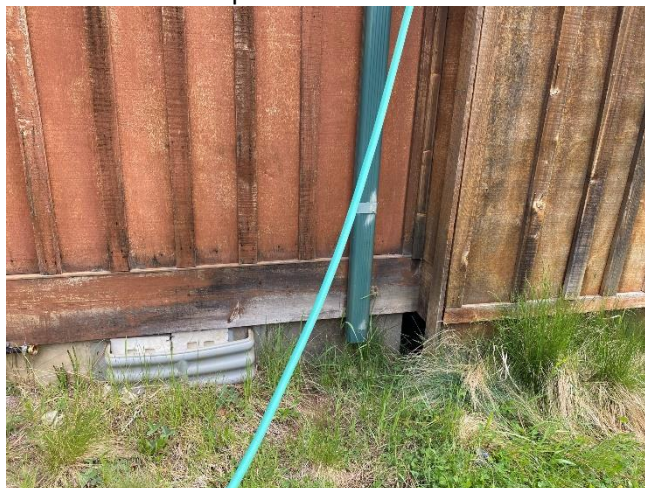
Siding Needs Re-finishing / Better Drainage to be Provided at Downspout

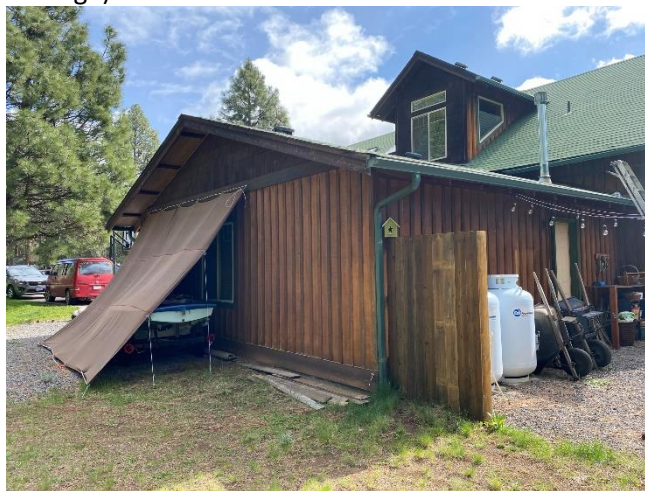
SouthWest (Side) Elevation of Residence (tarp is just providing cover to a boat, no siding damage)

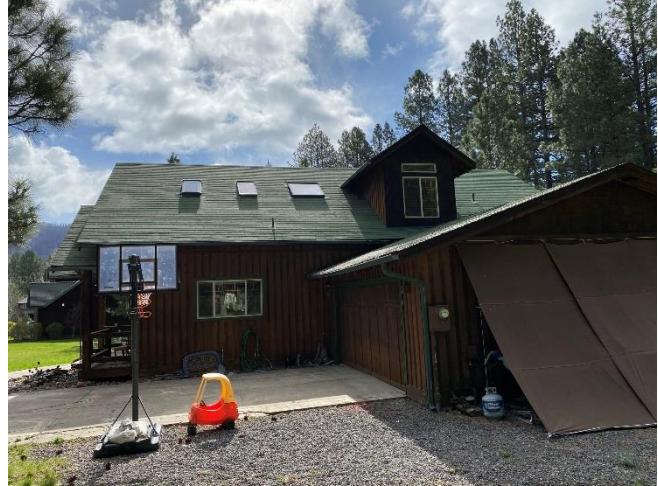
NorthWest (Side) Elevation of Residence

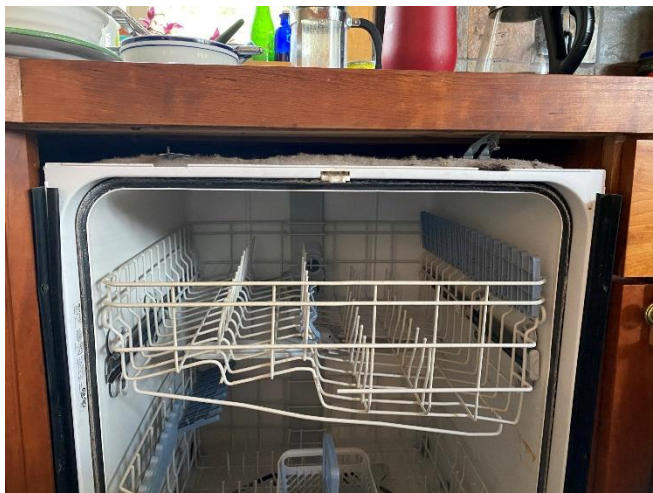
Dishwasher Not Mounted Properly

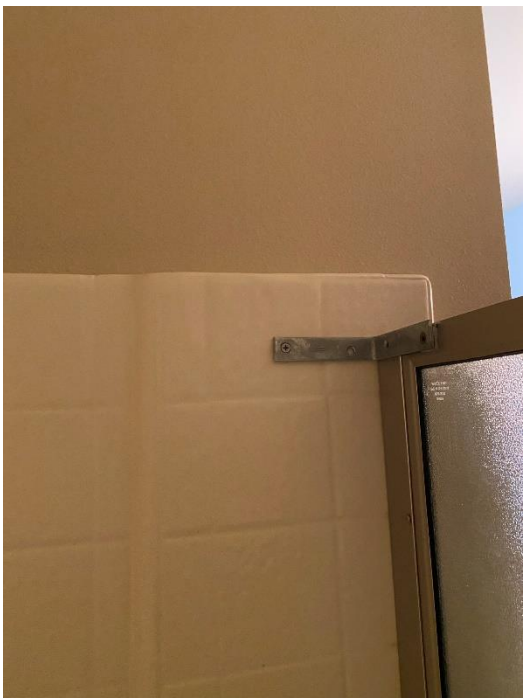
Master Bathroom Shower Enclosure Reinforcement

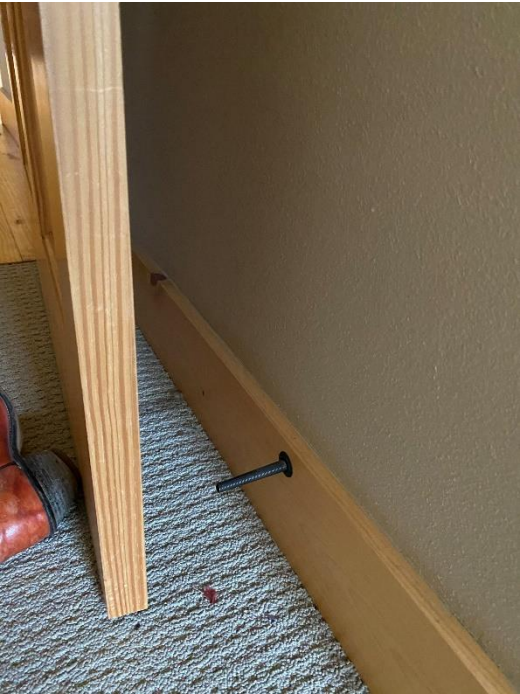
Master Bedroom Doorstop Needs Cover

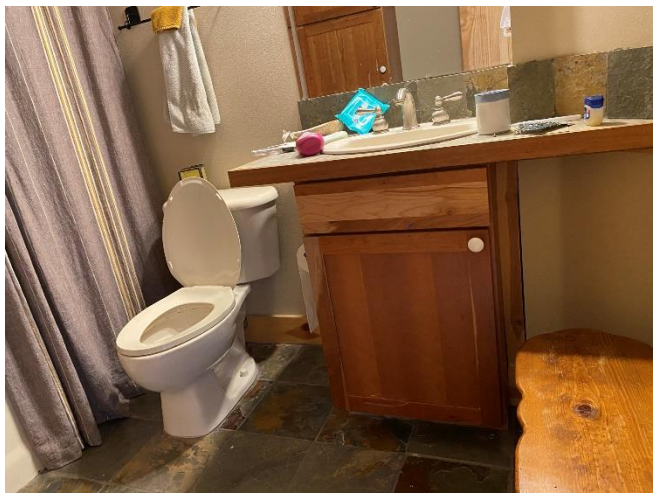
Upstairs Bathroom Cabinet Needs Refinishing

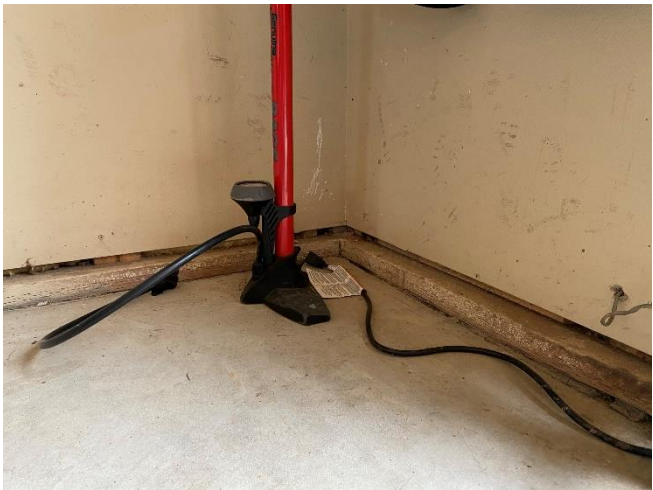
Garage Not Constructed with Concrete Curb

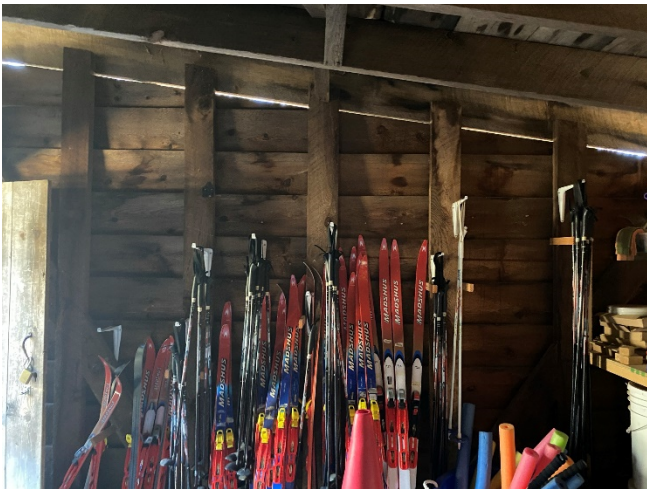
Eastern Bay – Interior

- Door hardware is non-accessible (building is too)
